# HISTORIC PRESERVATION COMMISSION MEETING

CITY OF DAVENPORT, IOWA

TUESDAY, OCTOBER 11, 2022; 5:00 PM

A. Case COA22-14: Request for exterior alteration at 613 West 6th Street. Isaac and Mary Farber House is located in the Local Historic Hamburg District. Lenny DeSantiago, petitioner. [Ward 3]

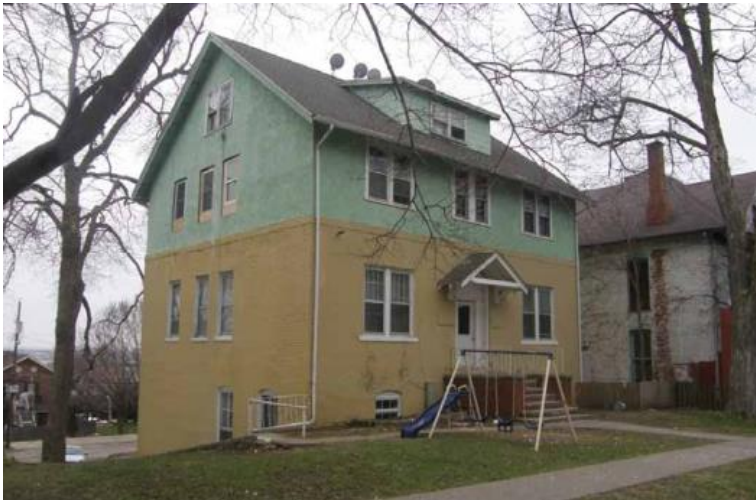
Northeast Elevation

- Built in 1868 as a 1-story brick home
- 1921: 2<sup>nd</sup> story addition. Home was converted to a 3-unit dwelling.
- 1945: Converted into 5 apartments
- 1950: Remodeled to 7 apartments

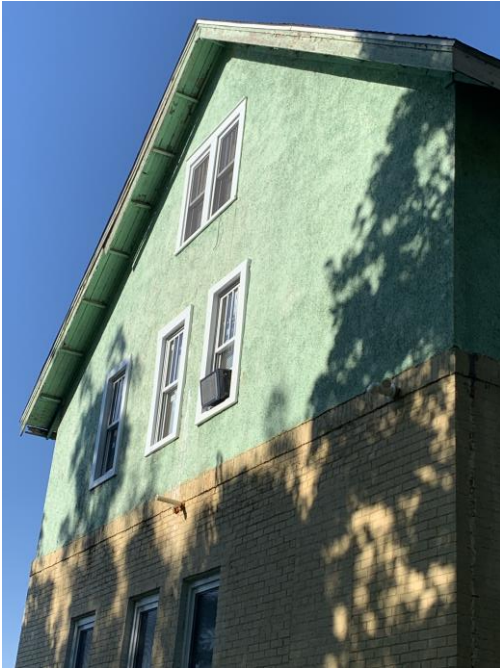
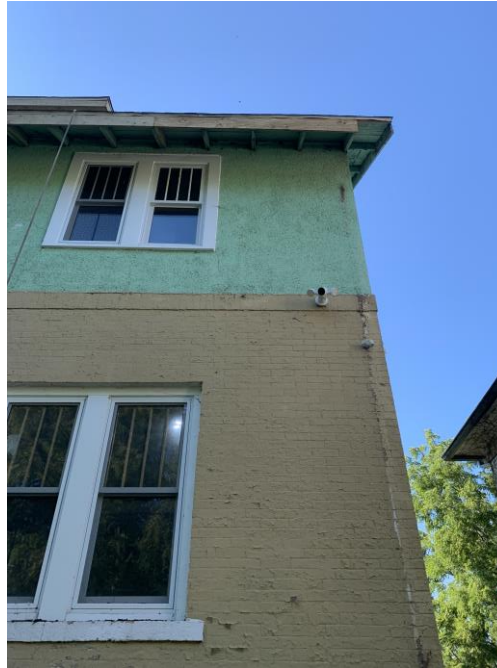
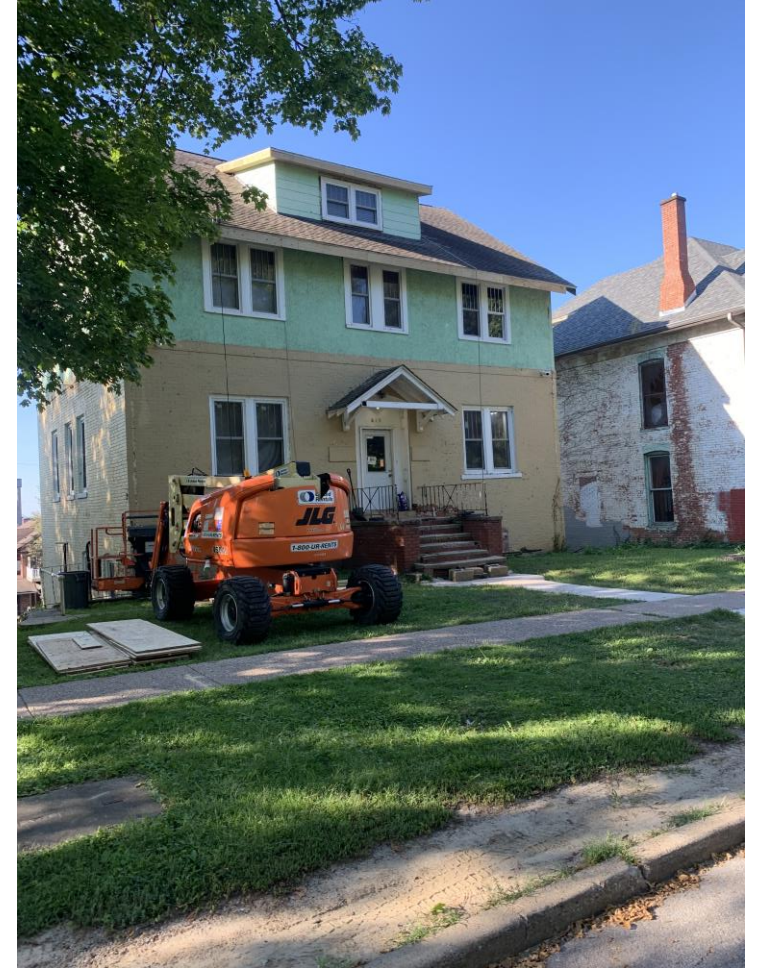
- Replaced rotted wood soffit and fascia with new treated wood.
- Install new white aluminum gutters.
- Paint building exterior.

I need to Replace <sup>only</sup> rotted wood on fascia and soffit to the building.  
Existing material wood. New material treated wood.

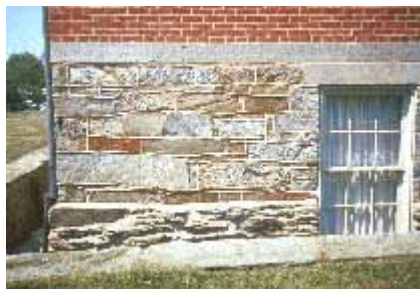
Materials and craftsmanship illustrated in stone wall.

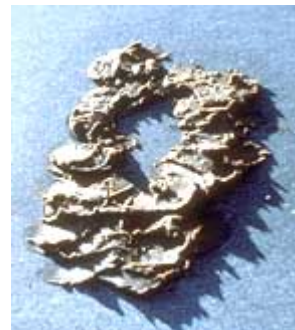
**Removing felt-tipped marker graffiti with poultice.**

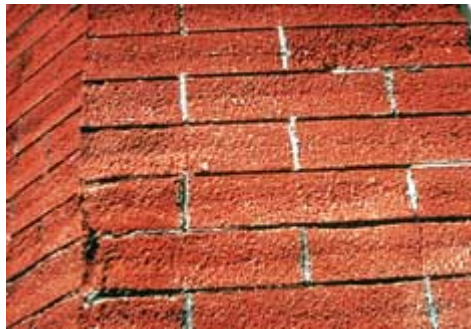
Historic brick damaged by sandblasting.

Sandblasting brick or stone surfaces using dry or wet grit or other abrasives. These methods of cleaning permanently erode the surface of the material and accelerate deterioration.

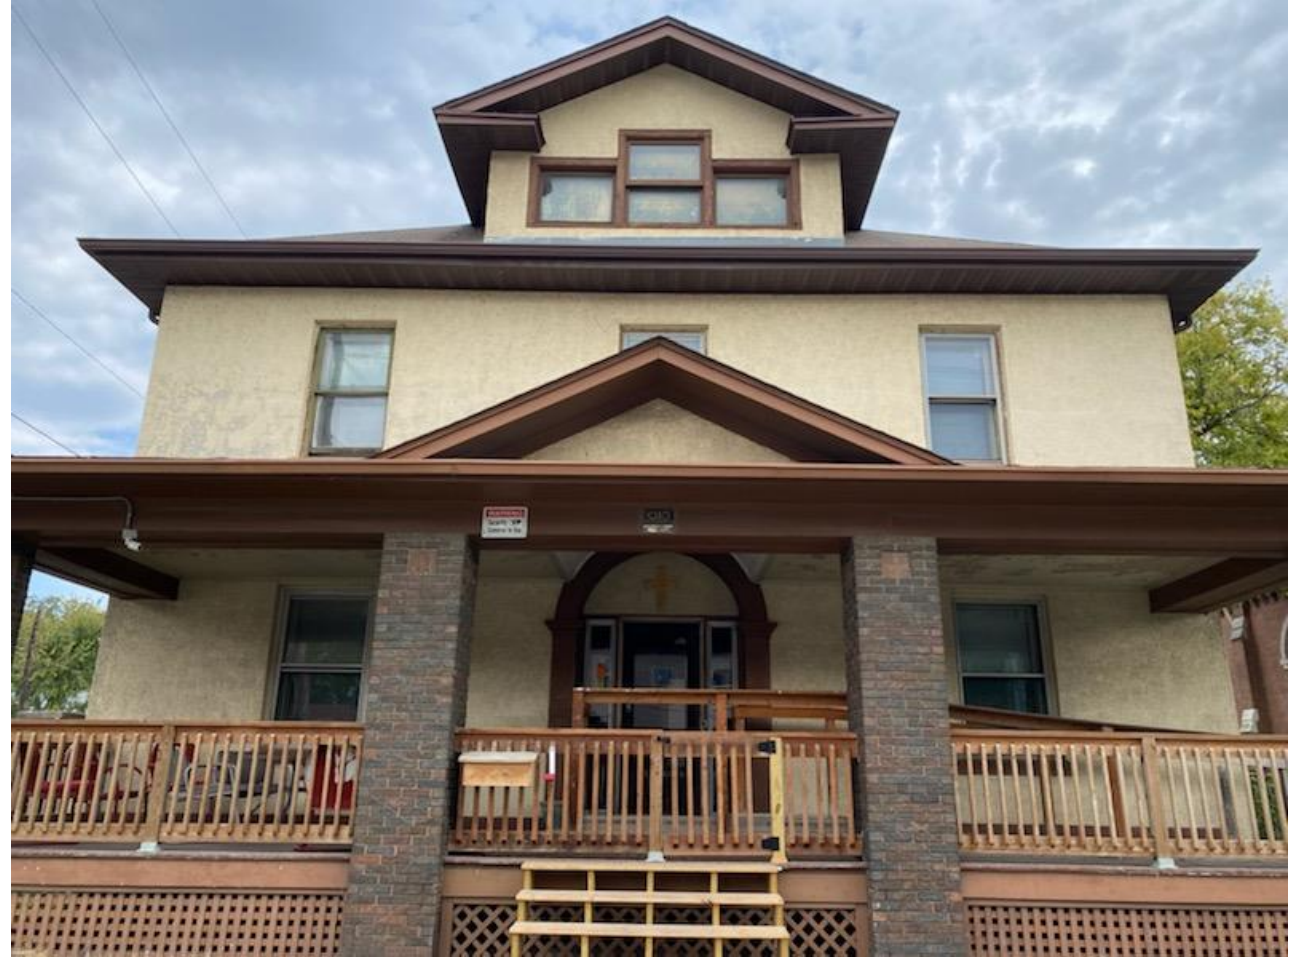
- Originally built for use as a church in 1855.
- Converted to a rectory in 1913.
- Exterior Alterations:
  - Gable roof changed to a hip roof with dormers
  - Rough-cut stone covered with stucco
  - Front porch addition
  - Arched windows changed to rectangular in shape
  - Addition of an oriel to the south/first floor

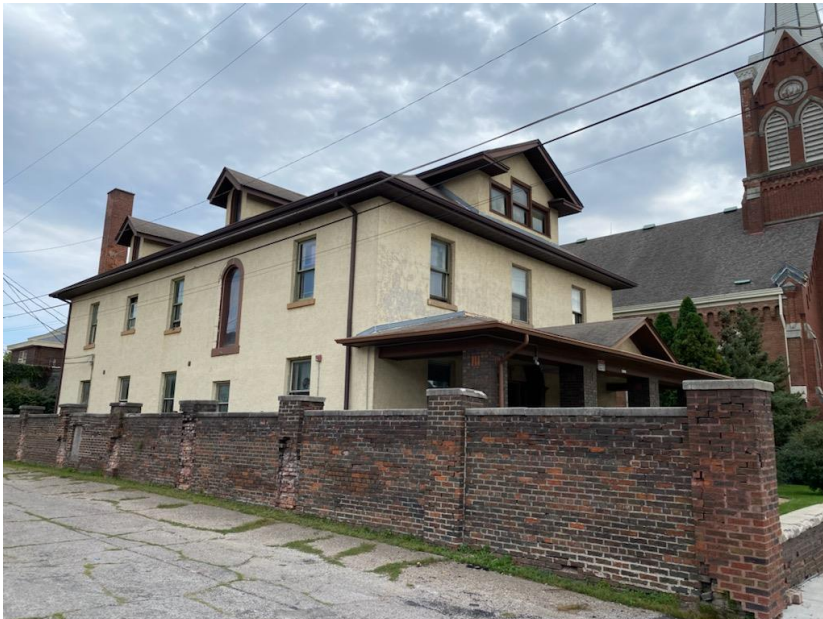
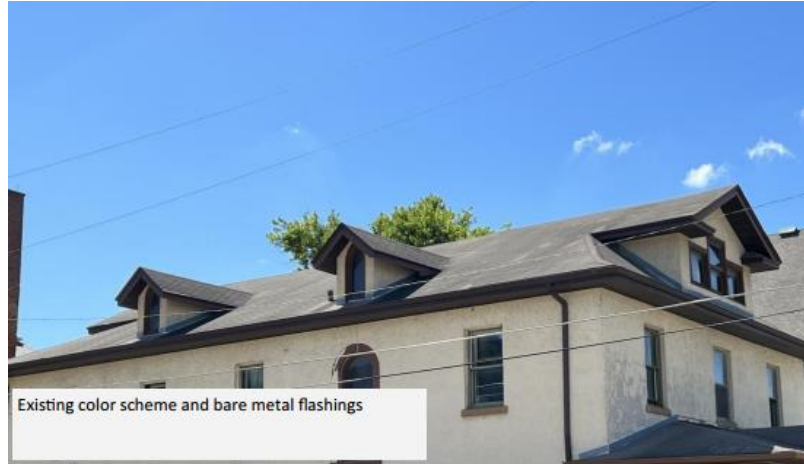
Existing color scheme and bare metal flashings

- **Existing Roof:** Grey Asphalt Shingle
- **Proposed Roof:** Brown Architectural Shingle
- Replace rooftop vents and flashing with new royal brown materials to match existing fascia and replacement roof color.

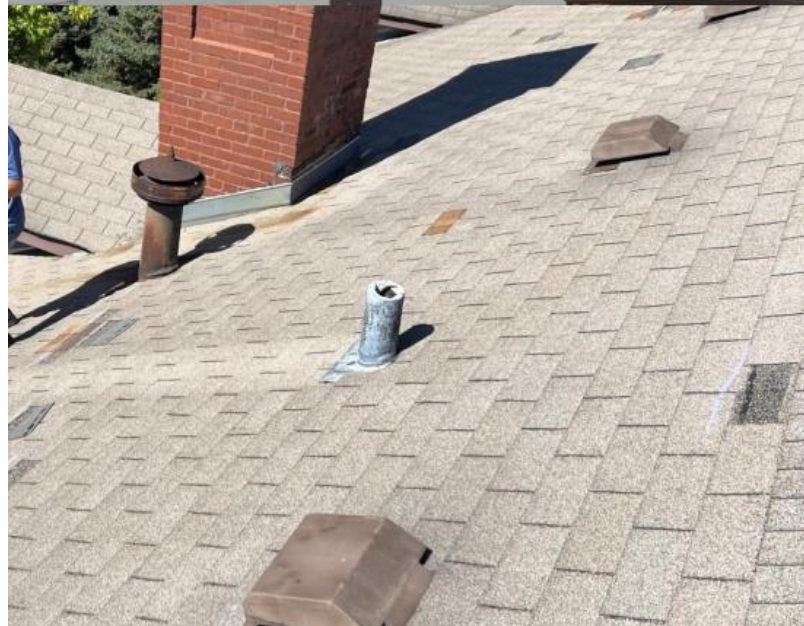
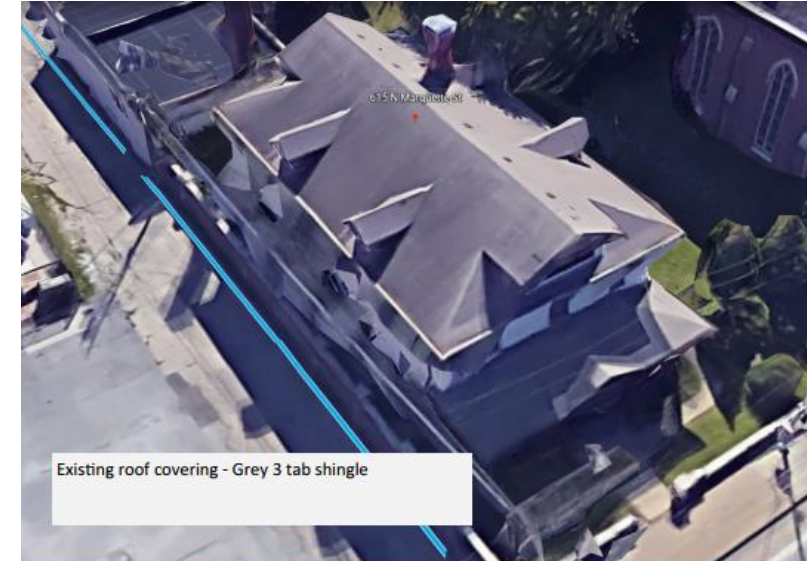
Existing roof covering - Grey 3 tab shingle

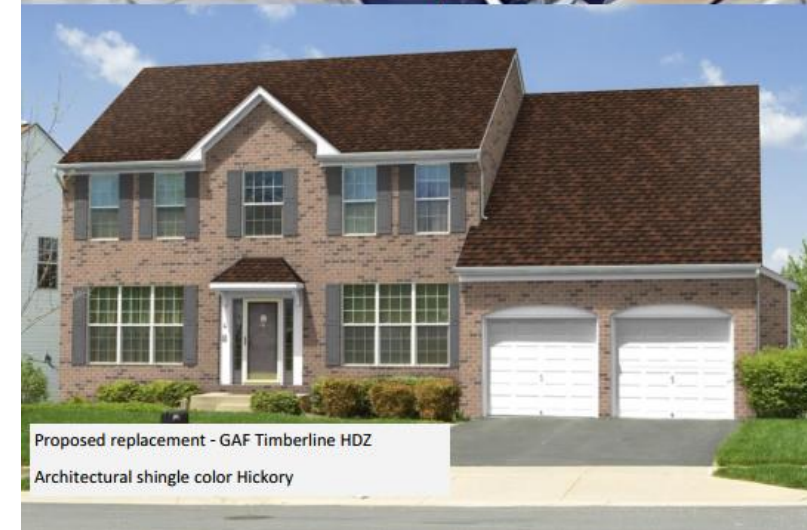
Proposed replacement - GAF Timberline HDZ  
Architectural shingle color Hickory

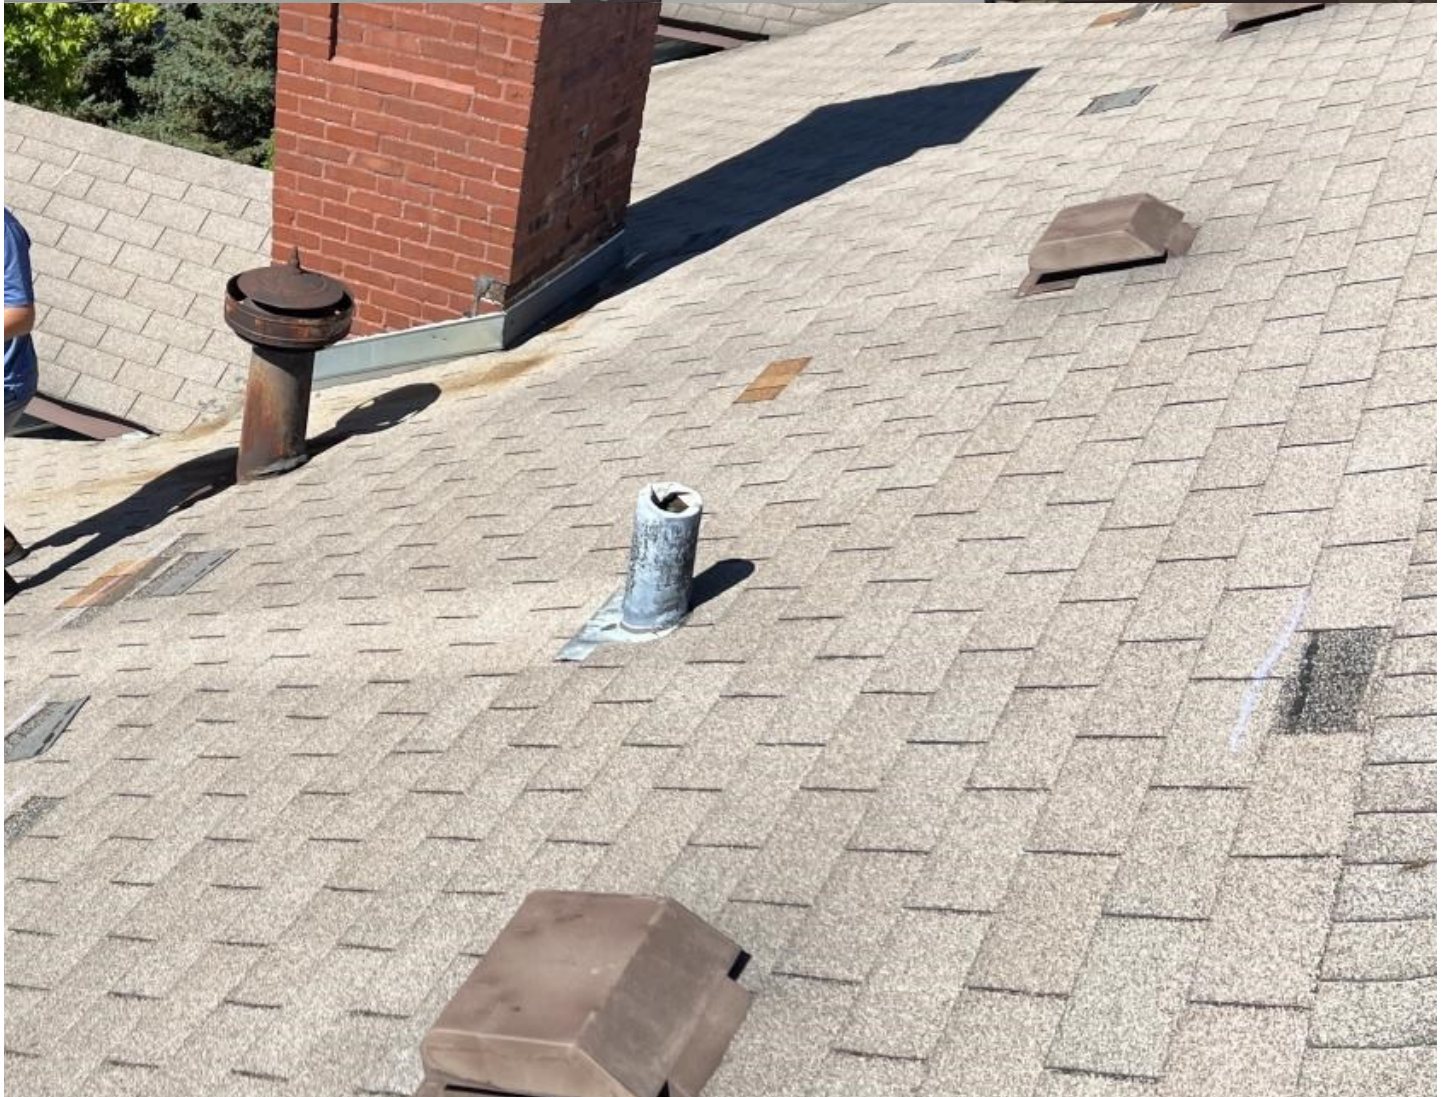
Existing roof covering - Grey 3 tab shingle

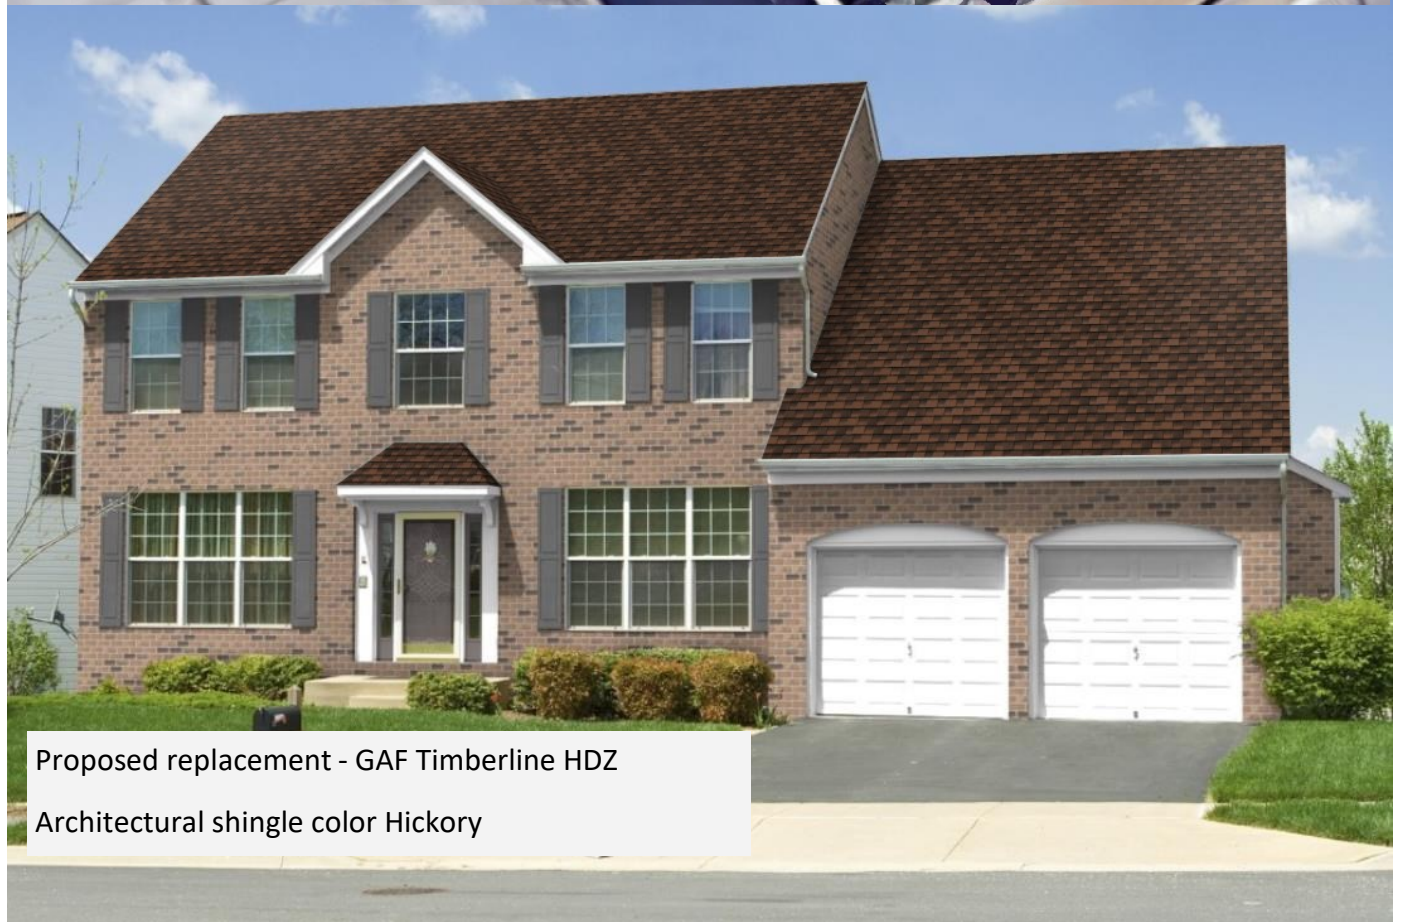
Proposed replacement - GAF Timberline HDZ

Architectural shingle color Hickory
