# HISTORIC PRESERVATION COMMISSION MEETING

CITY OF DAVENPORT, IOWA

Wednesday, July 17, 2024; 10:00 AM

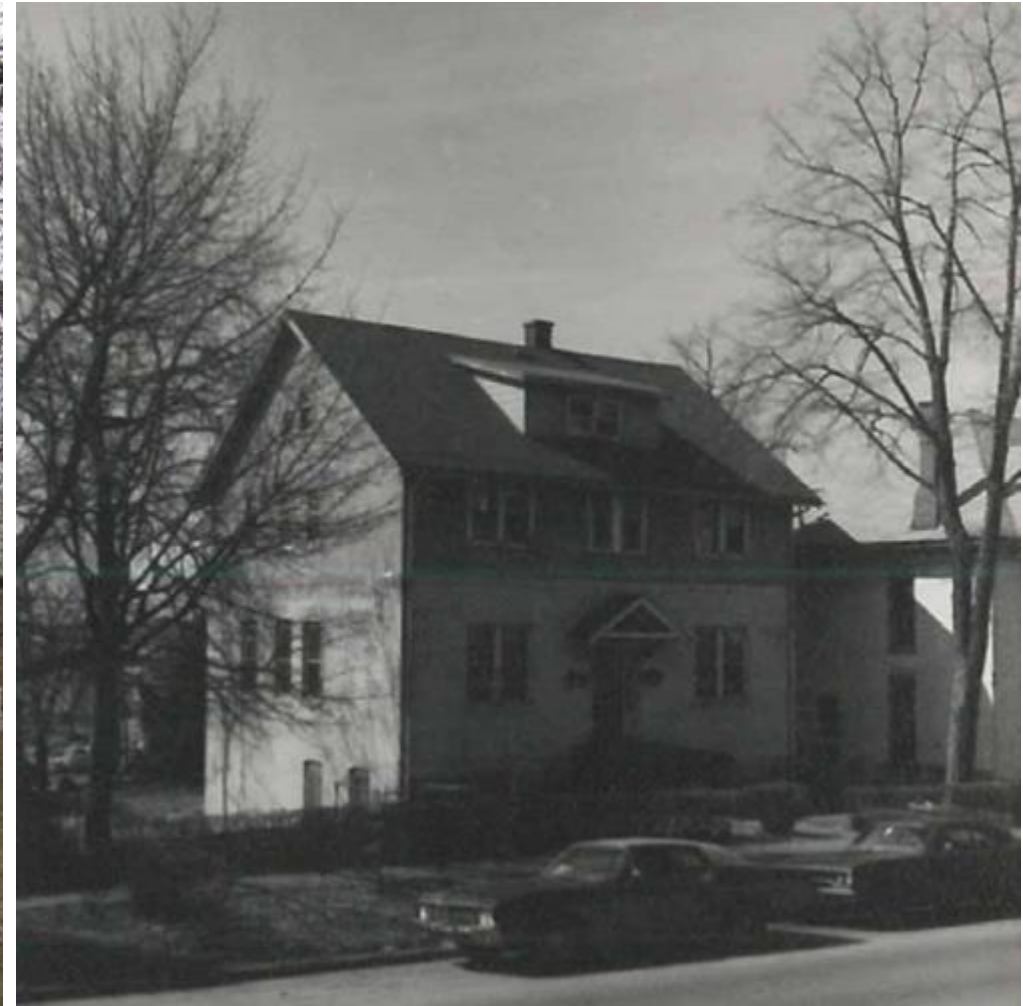
South Elevation

Photo from 1981/1982 Survey

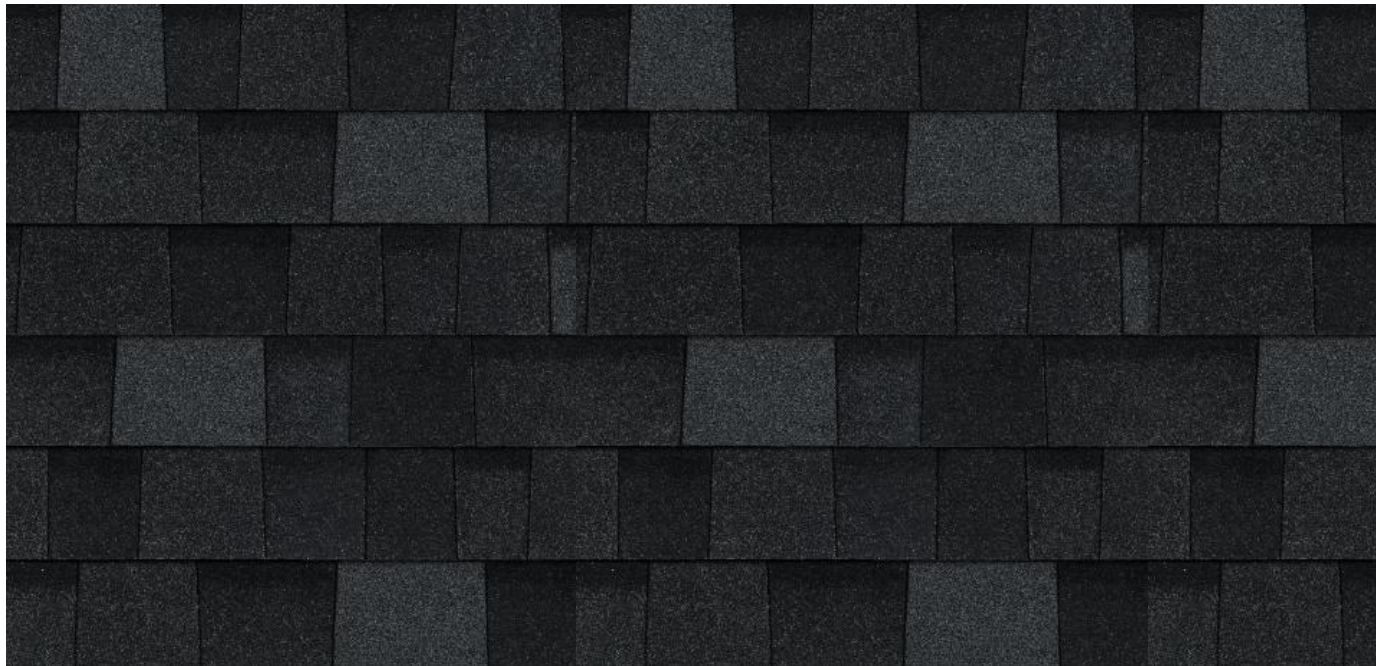
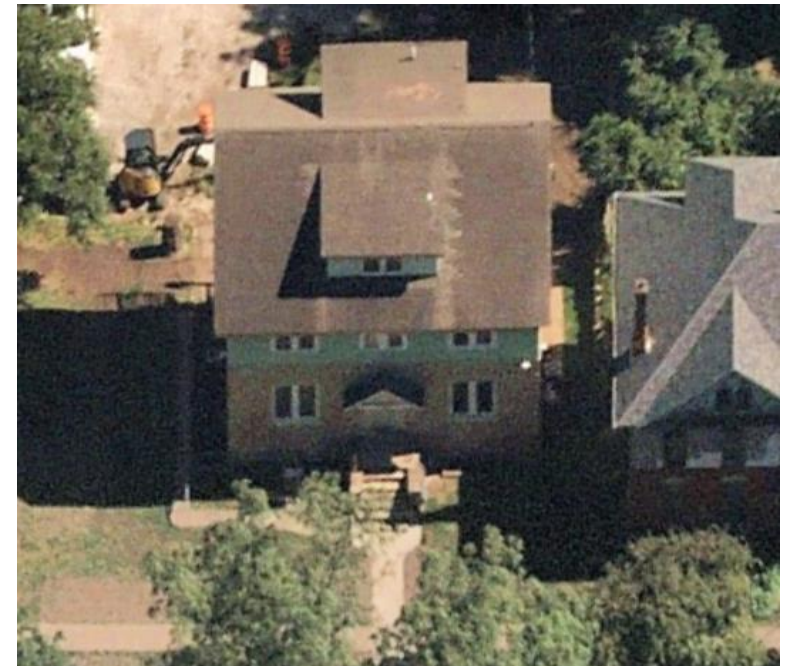
# Roof Replacement

- **Existing Material:** Asphalt Shingle
- **Proposed Material:** Architectural Asphalt Shingle
- **Product:** Owens Corning TruDefinition Duration Shingles

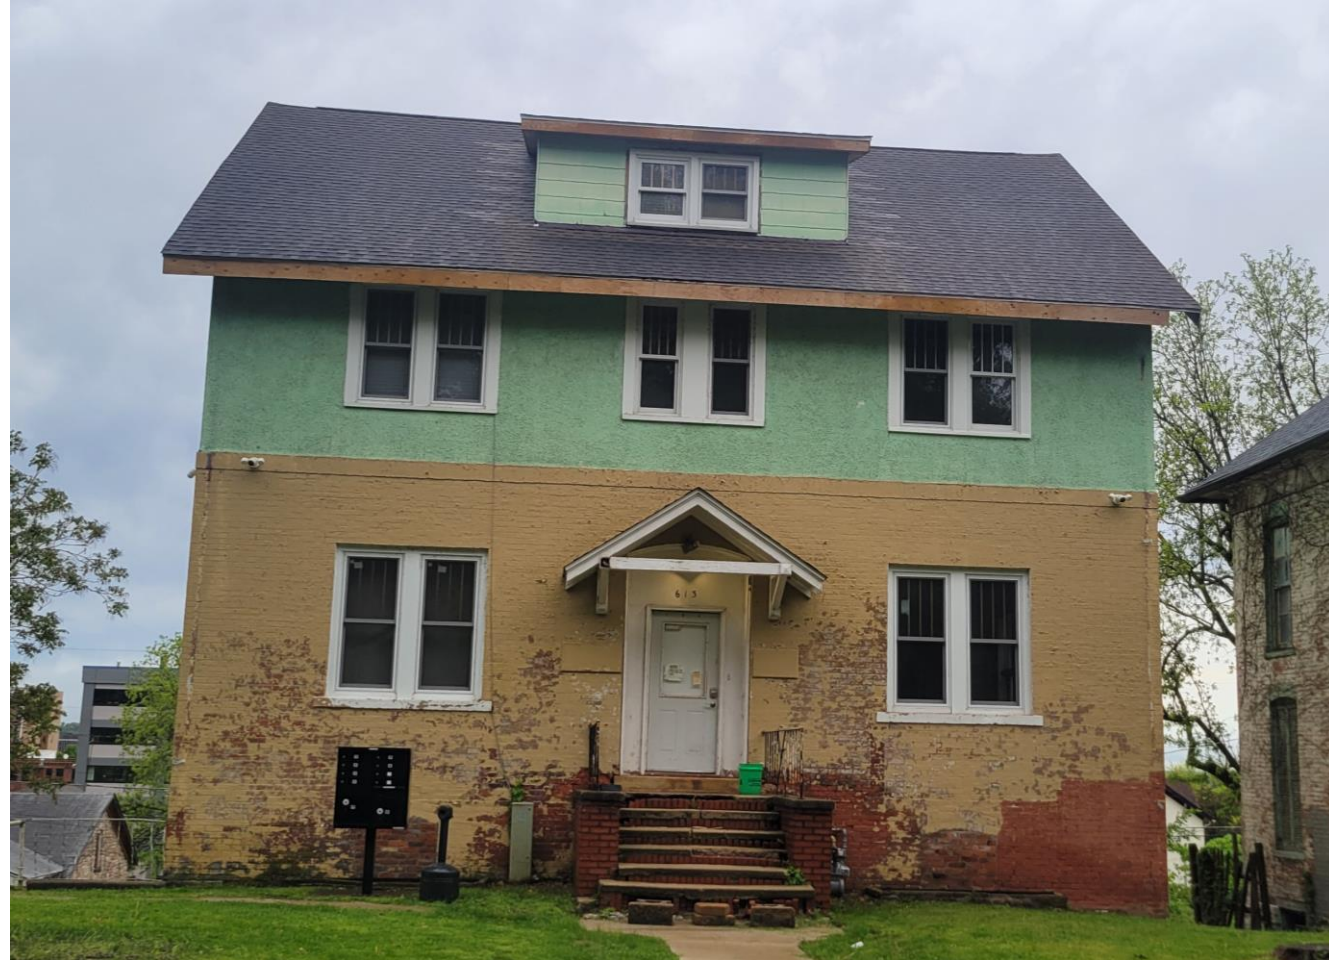
## 1. Lentil Replacement

- Demo lentils above doors & windows where damaged.
- Install historic brick on lentil.

- Grind out deteriorated mortar.
- Tuckpoint where needed.

## 3. Brick Replacement

- Remove any damaged bricks.
- Replace with historic bricks.

## 4. Clean Masonry

- Use SureKlean Vena Trol to clean surfaces where work is performed.

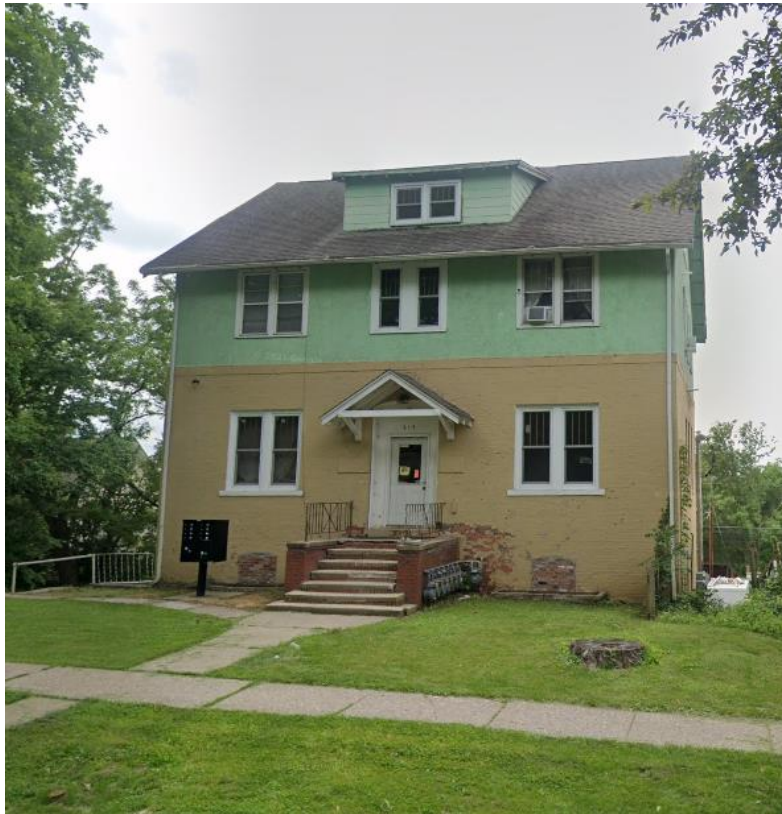
Before

# Paint Removal

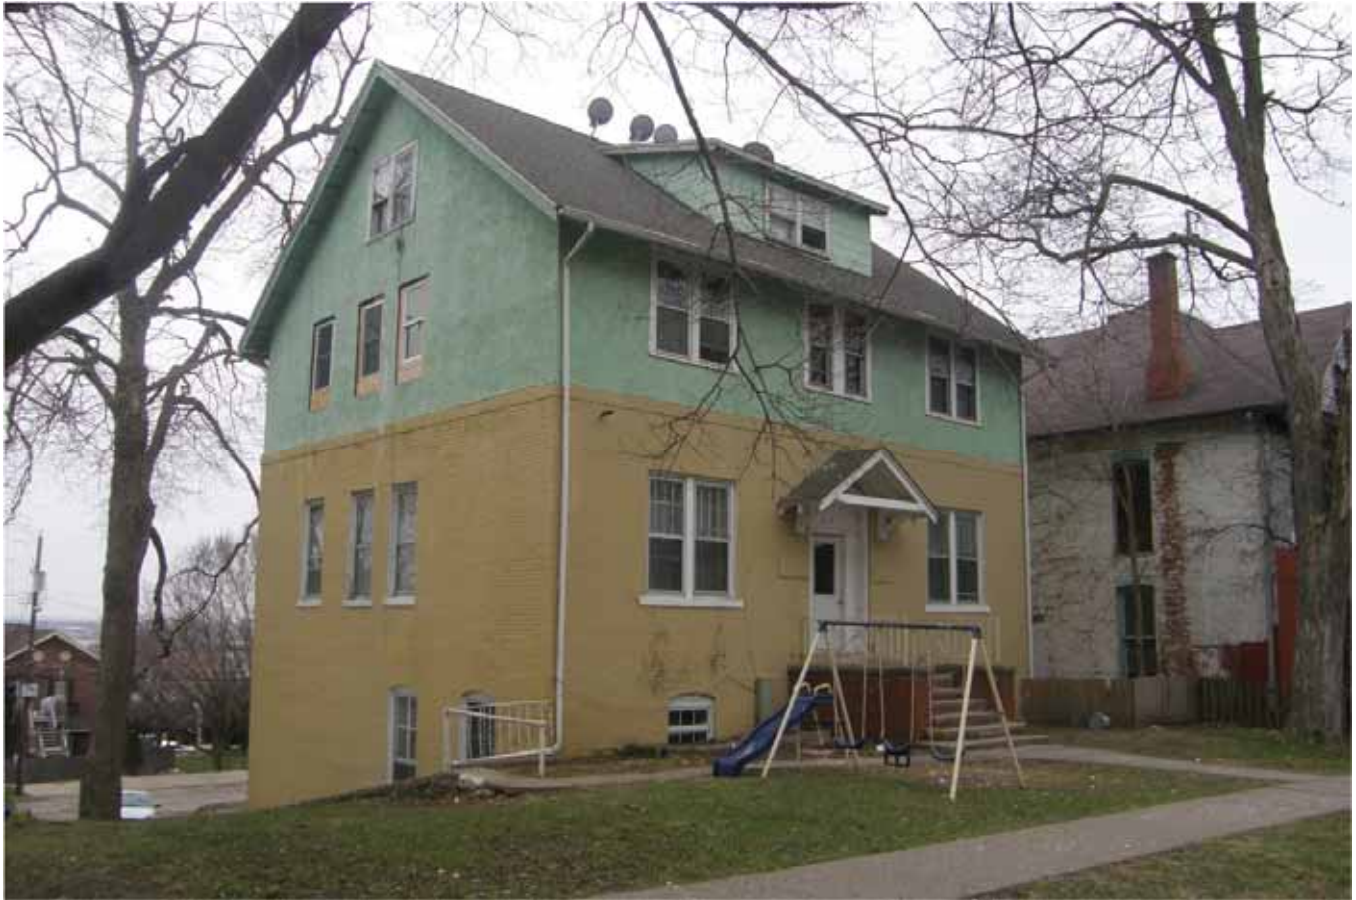
Photograph 82-00552-001 - House, looking southwest (April 2015)

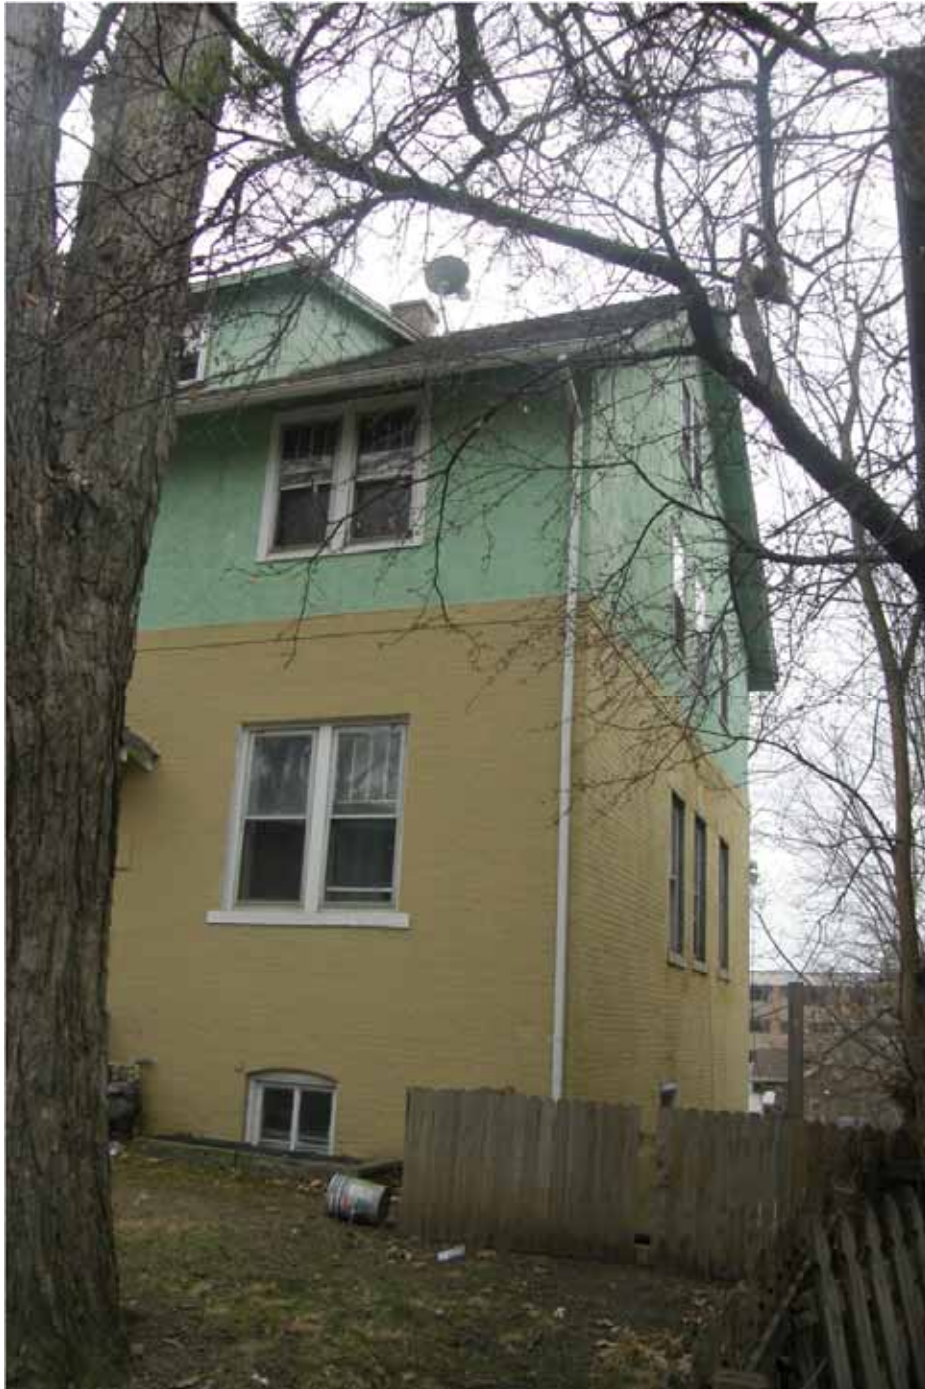
Photograph 82-00552-002 - House, looking southeast (April 2015)

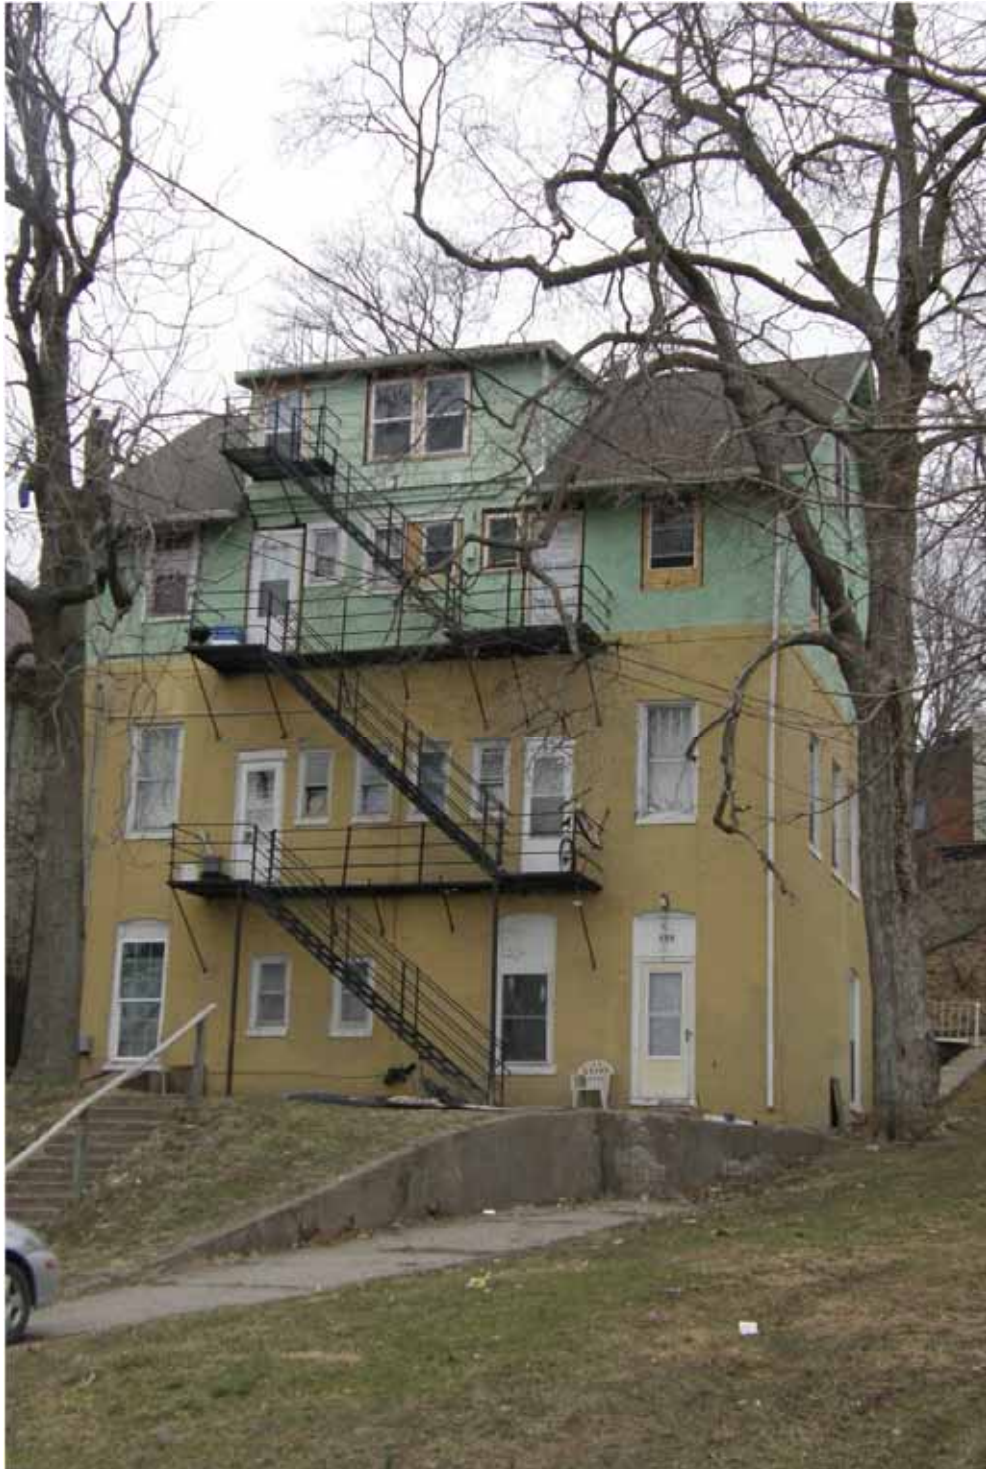
Photograph 82-00552-003 - House, looking northwest (April 2015)

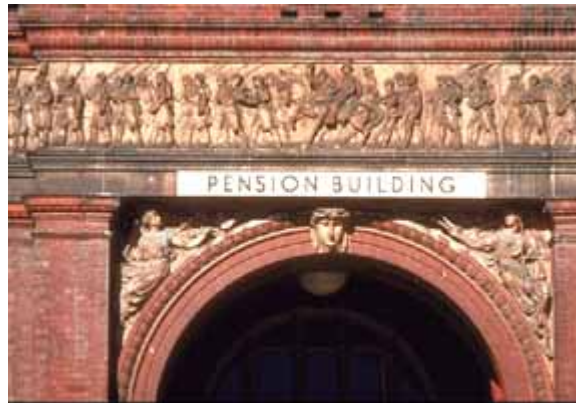
1880s brick building with terra-cotta trim.

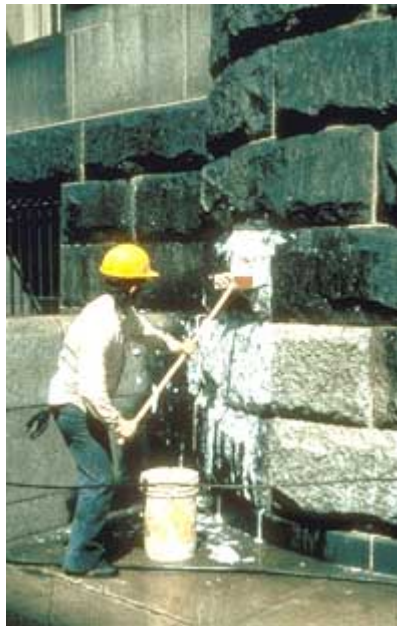
Chemical cleaning to remove dirt from granite.

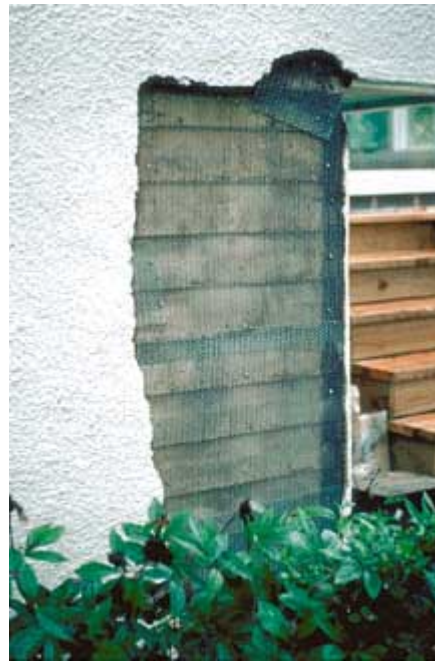
Preparation for stucco repair.

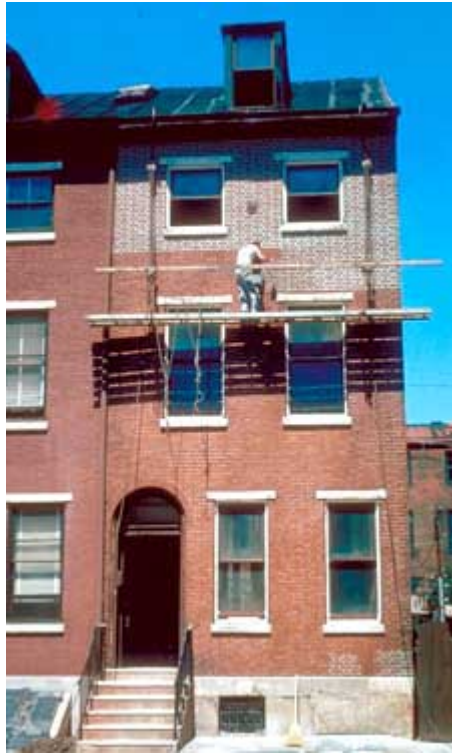
Loss of the historic character due to insensitive repointing.

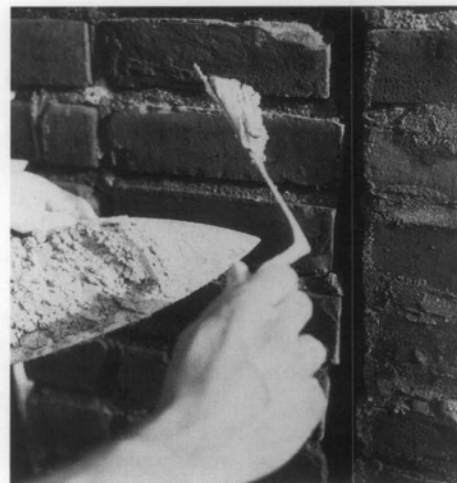
Figure 1. After removing deteriorated mortar, an experienced mason repoints a portion of this early-20th century limestone building. Photo: Robert C. Mack, FAIA.

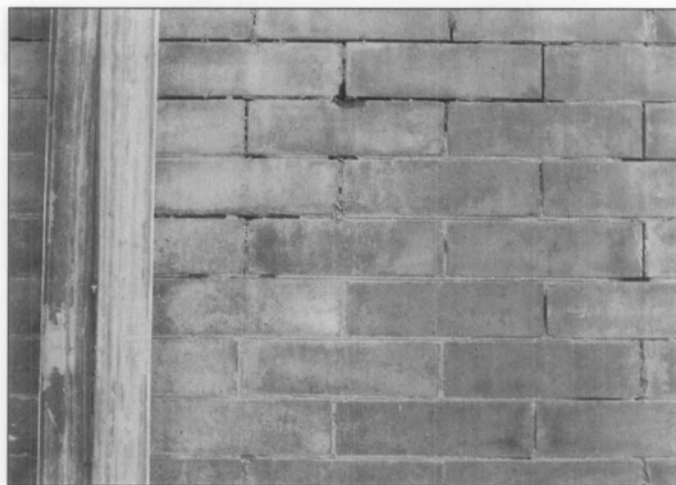
Figure 2. Much of the mortar on this building has been leached away by water from a leaking downspout. The downspout must be replaced and any other drainage problems repaired before repointing. Photo: Robert C. Mack, FAIA.

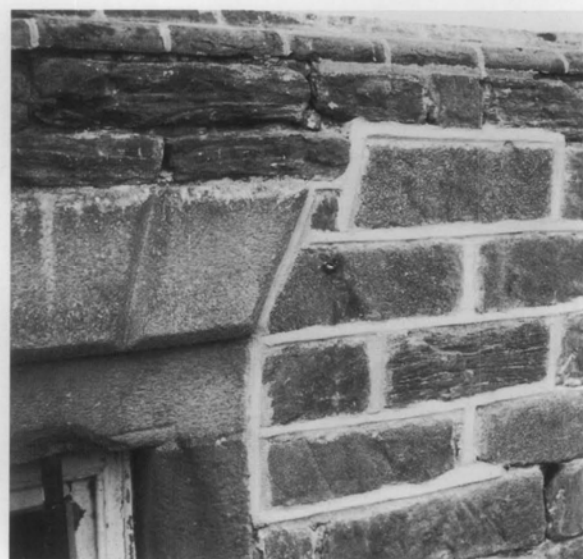
Figure 4. (left) The poor quality of this repointing—it appears to have been “tooled” with the mason’s finger—does not match the delicacy of the original beaded joint on this 19th-century brick wall. (right) It is obvious that the repointing on this “test patch” is not an appropriate replacement mortar joint for this early-19th century stone foundation. Photos: Lee H. Nelson, FAIA.

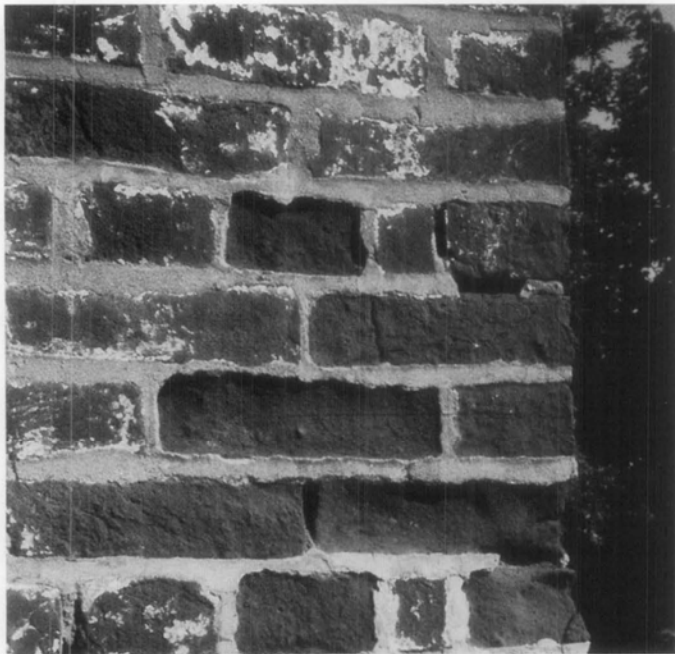
Figure 5. The use of hard, portland-cement mortar that is less permeable than the soft bricks has resulted in severe damage to this brick wall. Moisture trapped in the wall was unable to evaporate through the mortar which is intended to be sacrificial, and thus protect the bricks. As a result the moisture remained in the walls until water pressure eventually popped the surface off the bricks. Photo: National Park Service Files.

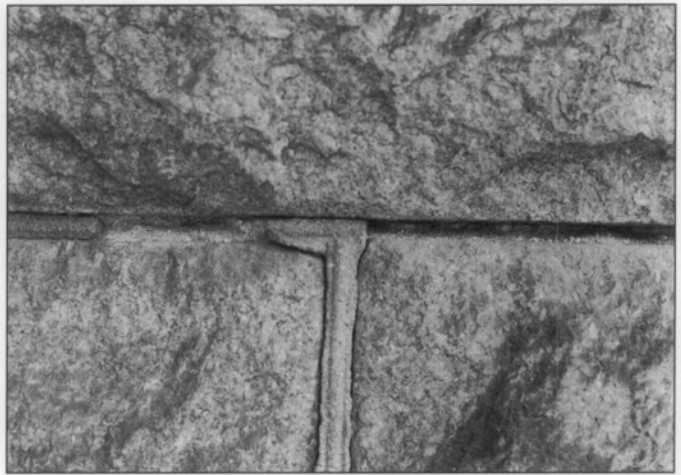
Figure 8. Due to inadequate joint preparation, the repointing mortar has not adhered properly and is falling out of the joint. Photo: Robert C. Mack, FAIA.

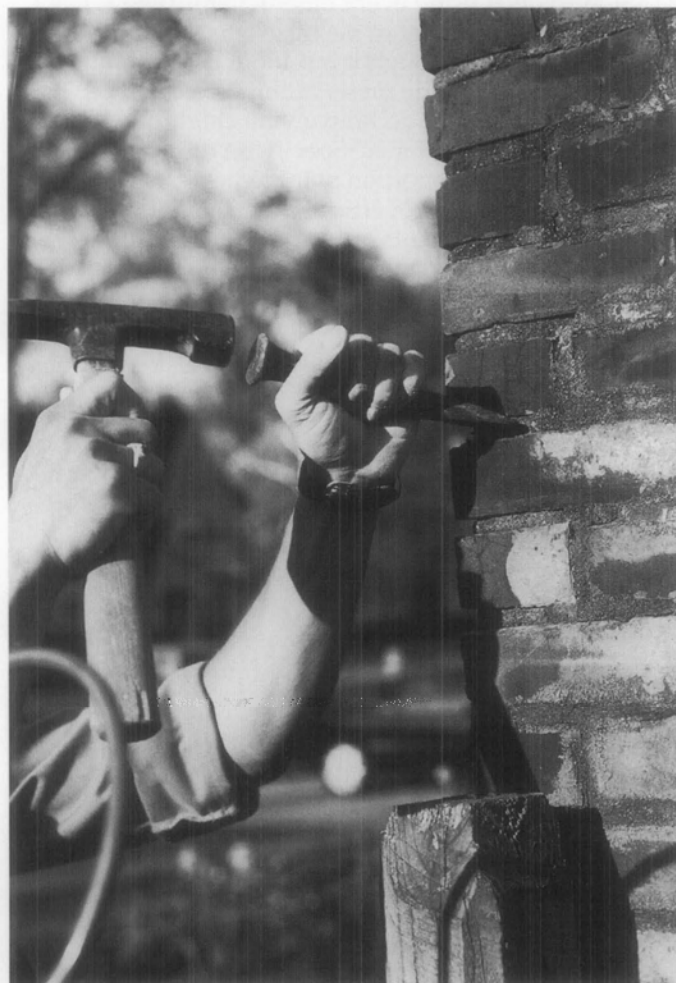
Figure 10. Using a hammer and masonry chisel is the least damaging and, thus, generally the preferred method of removing old mortar in preparation for repointing historic masonry. Photo: John P. Speweik.

Although some damage may be inevitable, careful joint preparation can help limit damage to masonry units. The traditional manner of removing old mortar is through the use of hand chisels and mash hammers (Fig. 10). Though labor-intensive, in most instances this method poses the least threat for damage to historic masonry units and produces the best final product.

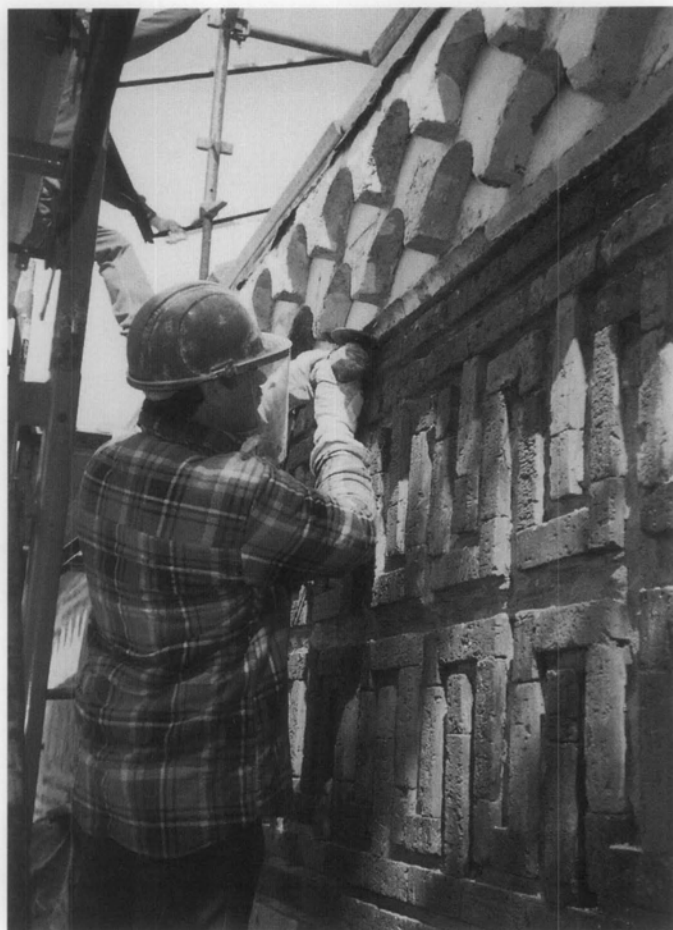
Figure 12.. A power grinder, operated correctly by a skilled mason may be used in preparation for repointing to cut wide, horizontal mortar joints, typical of many early-20th century brick structures without causing damage to the brick. Note the use of protective safety equipment. Photo: Robert C. Mack, FAIA.

Under certain circumstances, thin diamond-bladed grinders may be used to cut out *horizontal* joints only on hard portland cement mortar common to most early-20th century masonry buildings (Fig. 12). Usually, automatic tools most successfully remove old mortar without damaging the masonry units when they are used in combination with hand tools in preparation for repointing. Where horizontal joints are uniform and fairly wide, it may be possible to use a power masonry saw to assist the removal of mortar, such as by cutting along the middle of the joint; final mortar removal from the sides of the joints still should be done with a hand chisel and hammer. Caulking cutters with diamond blades can sometimes be used successfully to cut out joints without damaging the masonry. Caulking cutters are slow; they do not rotate, but vibrate at very high speeds, thus minimizing the possibility of damage to masonry units (Fig. 13). Although mechanical tools may be used safely in limited circumstances to cut out horizontal joints in preparation for repointing, they should never be used on vertical joints because of the danger of slipping and cutting into the brick above or below the vertical joint. Using power tools to remove mortar without damaging the surrounding masonry units also necessitates highly skilled masons experienced in working on historic masonry buildings. Contractors

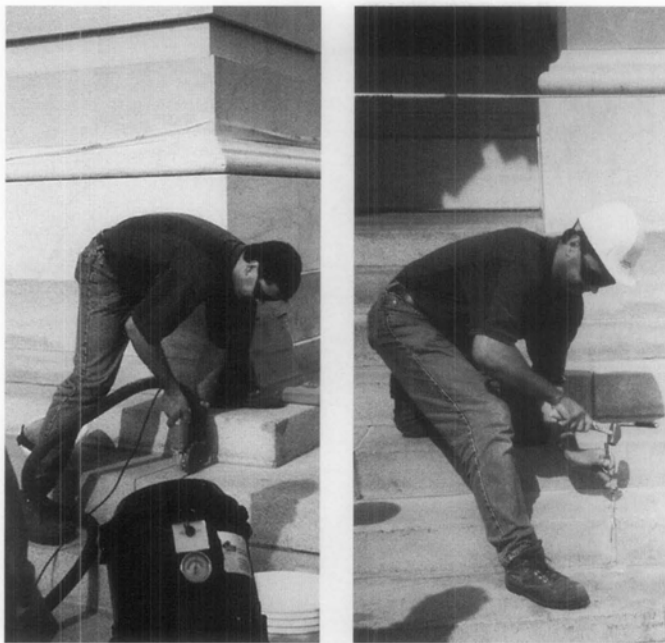
Figure 13. (left) In preparation for repointing, the mortar joints on these granite steps are first cut out mechanically (note the vacuum attached to the cutting tool in foreground to cut down on dust). (right) Final removal of the old mortar is done by hand to avoid damage to the edges of the joints. Mechanical preparation of horizontal joints by an experienced mason may sometimes be acceptable, especially where the joints are quite wide and the masonry is a very hard stone. Photos: Anne Grimmer.

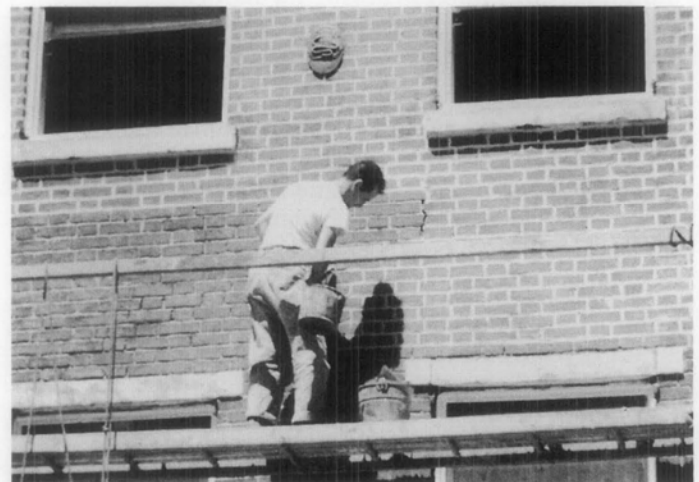
Figure 17. This photograph shows the significant visual change to the character of this historic brick building that has resulted from improper repointing procedures and a noticeably increased thickness of the mortar joints. Photo: Lee H. Nelson, FAIA.

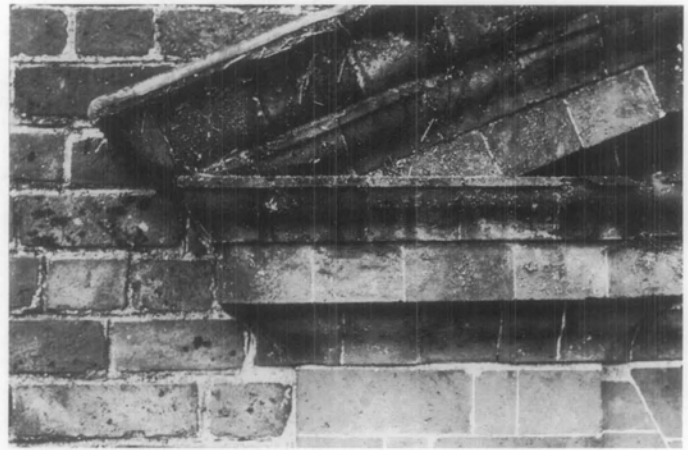
Figure 19. Mortar joints of 18th century brick buildings were often as much as 1/2 inch wide, cut flush and struck with a grapevine joint, but for window and door surrounds where a finer quality rubbed brick was used, mortar joints were very thin. Photo: National Park Service Files.

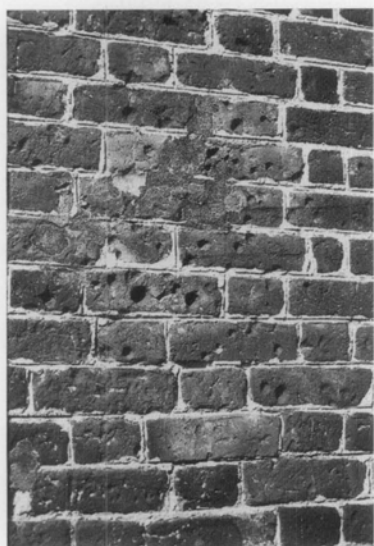
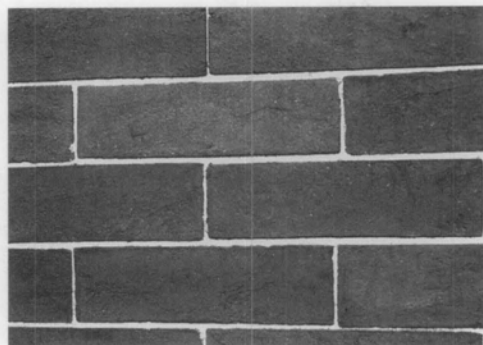
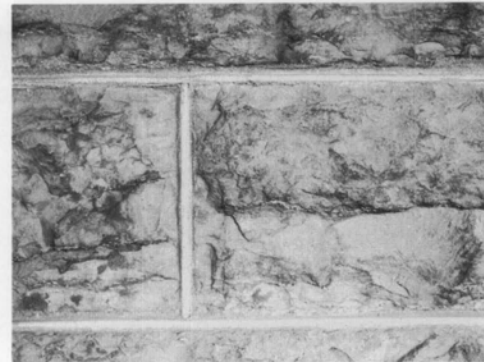
Figure 18. A cross-section of mortar joint types. (a) Grapevine joints on a mid-18th century brick building; (b) flush joints on a mid-to-late 19th century brick building; (c) beaded joints on a late-19th century brick building; (d) early-20th century beaded joints on rough-cut limestone where the vertical joints were struck prior to the horizontal joints; (e) raked joints on 1920s wire brick; (f) horizontal joints on a 1934 building designed by Frank Lloyd Wright were raked back from the face of the bricks, and the vertical joints were filled with a red-tinted mortar to emphasize the horizontality of the narrow bricks, and struck flush with the face of the bricks; (g) the joints on this 20th century glazed terracotta tile building are raked slightly, emphasizing the glazed block face. Photos: National Park Service Files (a,b,e); Robert C. Mack, FAIA (c,d,f,g).

**Pointing Style.** Close examination of the historic masonry wall and the techniques used in the original construction will assist in maintaining the visual qualities of the building (Fig. 18). Pointing styles and the methods of producing them should be examined. It is important to look at both the horizontal and the vertical joints to determine the order in which they were tooled and whether they were the same style. Some late-19th and early-20th century buildings, for example, have horizontal joints that were raked back while the vertical joints were finished flush and stained to match the bricks, thus creating the illusion of horizontal bands. Pointing styles may also differ from one facade to another; front walls often received greater attention to mortar detailing than side and rear walls (Fig. 19).

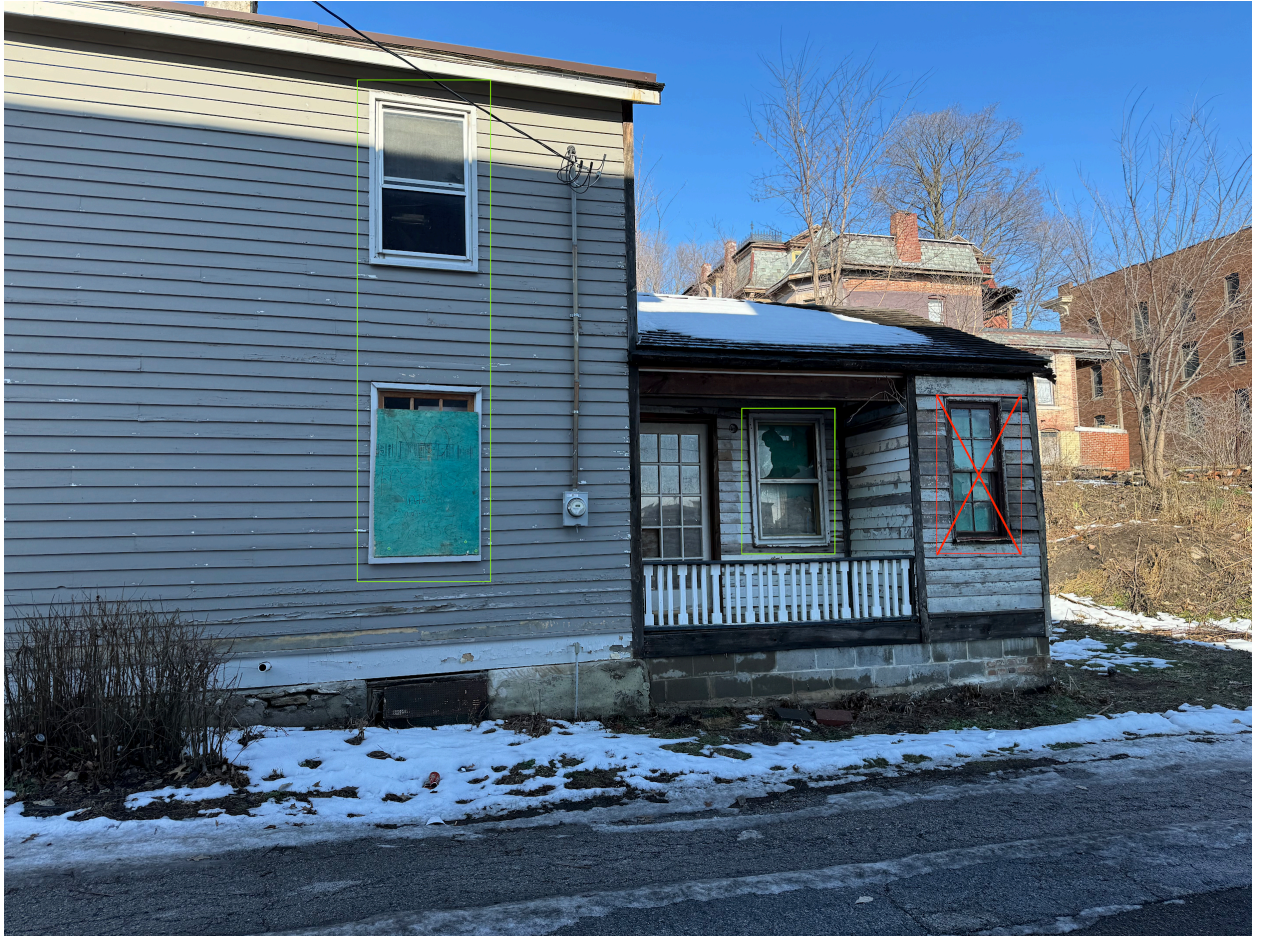
- ☐ Eliminate window on 1 story kitchen / bathroom addition south wall in east corner indicated in red, replace siding with like-kind wood clapboard.

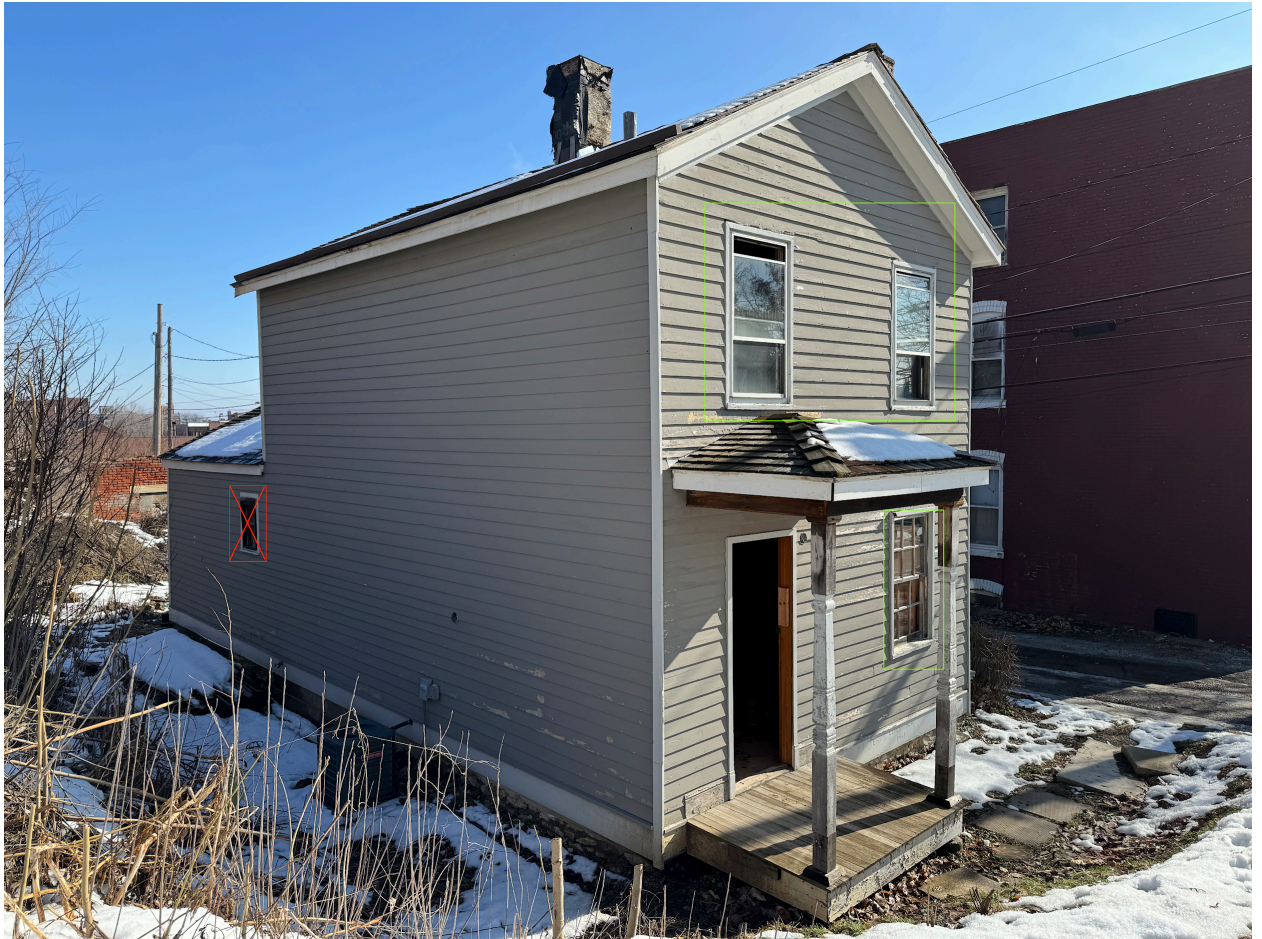
- ☐ Side over former window opening on northern elevation of 1 story kitchen / bathroom addition indicated in red with like-kind wood clapboard (see interior photo indicating existing eliminated window).

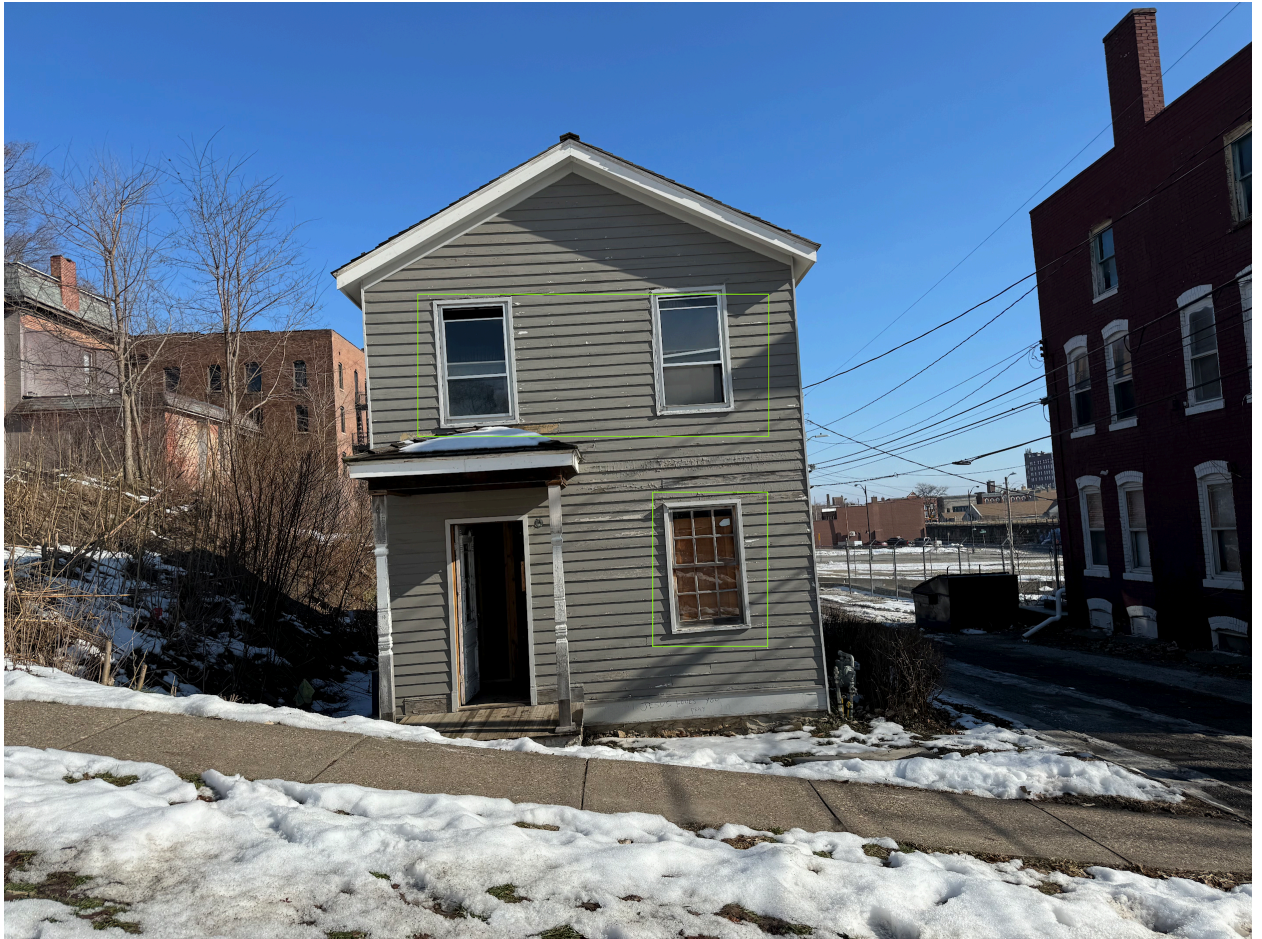
- ☐ Replace existing windows throughout indicated in green with like-kind Pella Lifestyle series.

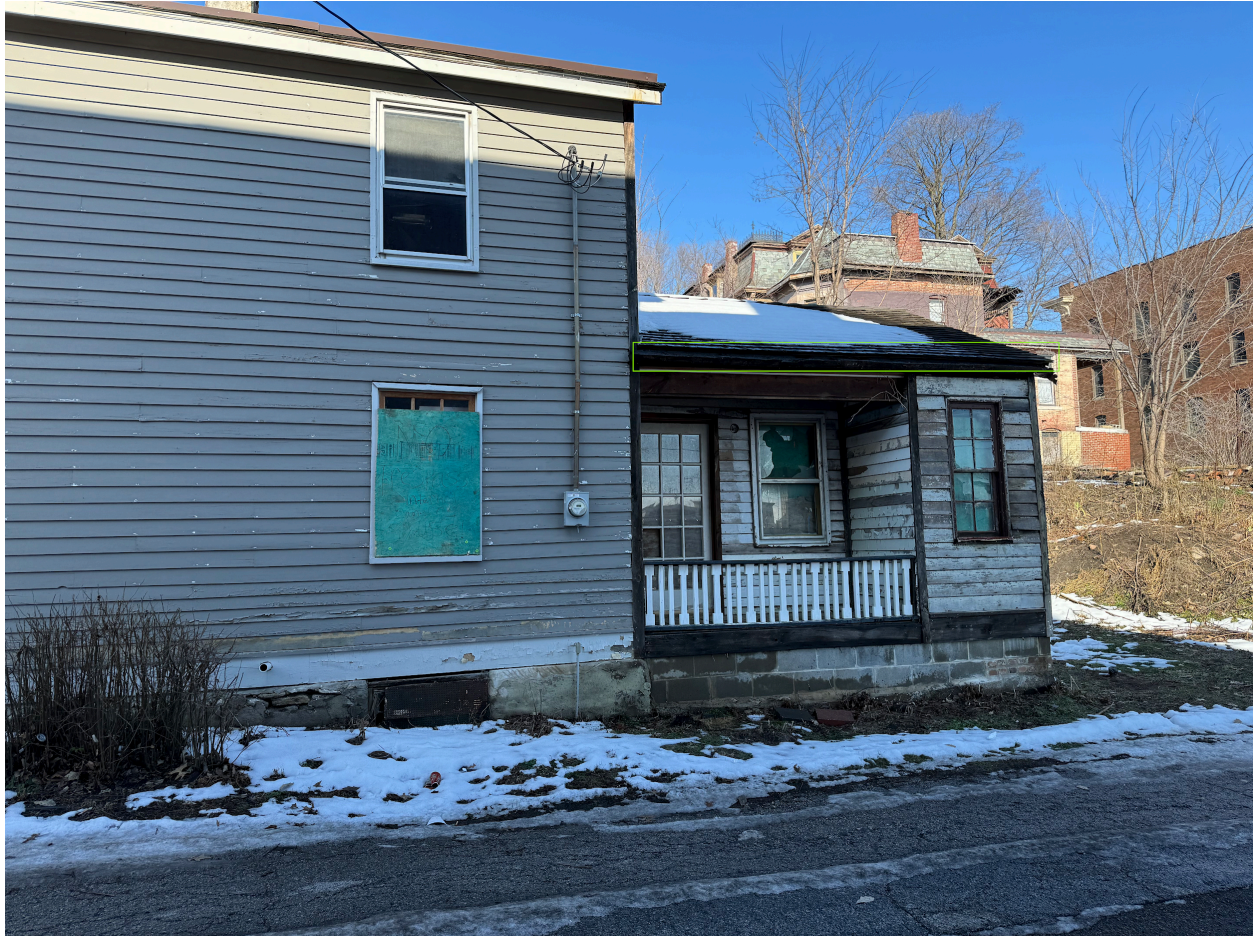
- ☐ Install aluminum downspouts to existing yankee gutters on North & Southeast corners of 2 story house.
- ☐ Replace existing deteriorated gutters on north and south elevation of 1 story kitchen and bathroom addition indicated in green with like-kind aluminum half round gutters & downspouts.

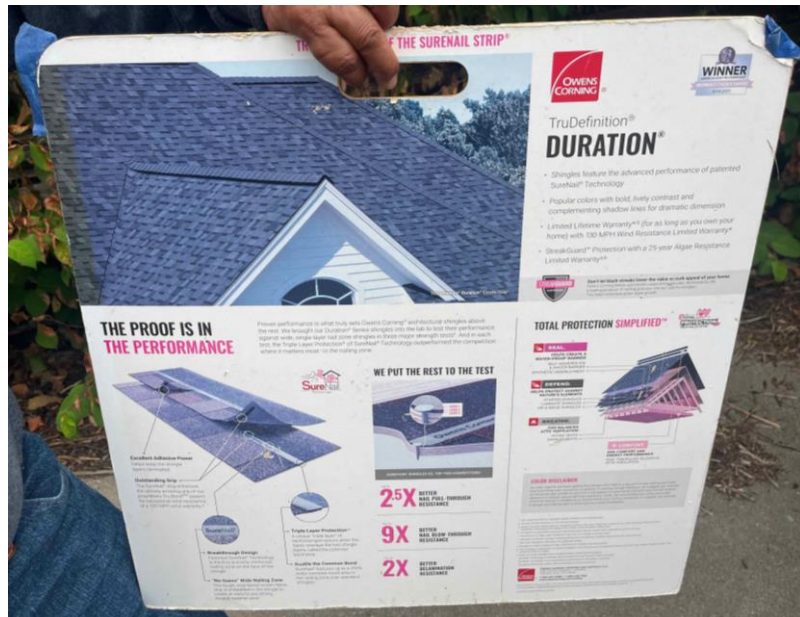
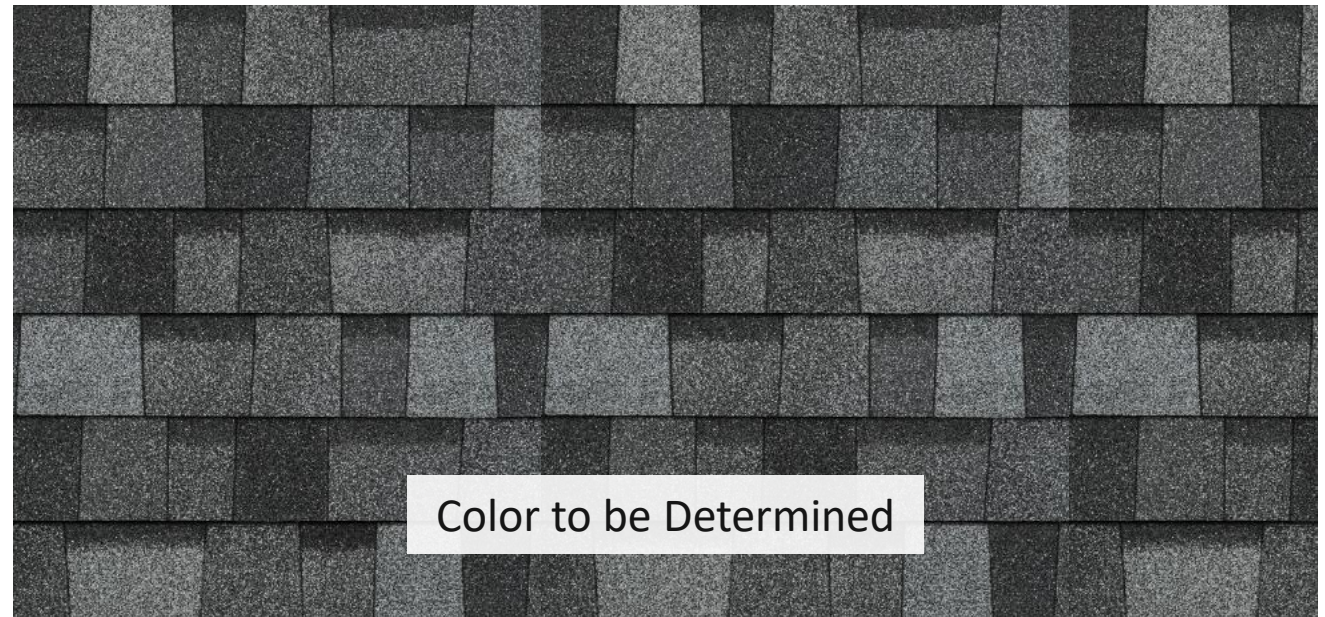
- Install Asphalt Shingle Roof & Gutter System
- **Existing Material:** Asphalt Shingle
- **Proposed Material:** Architectural Asphalt Shingle
- **Product:** Owens Corning TruDefinition Duration Shingles

Color to be Determined

**Request:** Installation of a new roof and gutters. The proposed replacement product is Owens Corning TruDefinition Duration Shingles.

The historic property inventory sheet identifies the roofing material as asphalt shingle. Based on prior building permits, the existing roof appears to be a 3-tab shingle. The benefits of the proposed architectural shingle include enhanced durability, better wind resistance, improved waterproofing capabilities, and a more dimensional appearance for added curb appeal. Staff consider the installation of an architectural shingle to be a replacement in-kind.
