# HISTORIC PRESERVATION COMMISSION MEETING

CITY OF DAVENPORT, IOWA

Wednesday, July 17, 2024; 10:00 AM

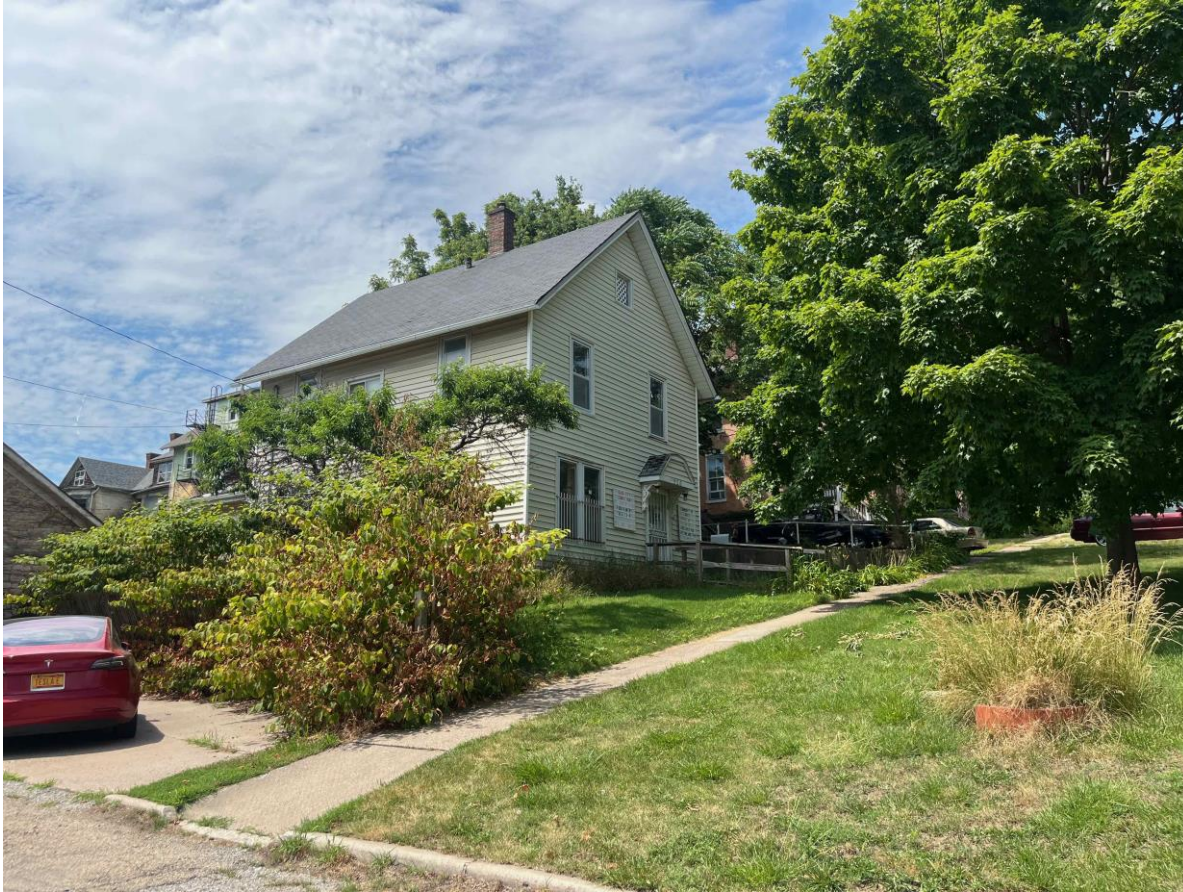
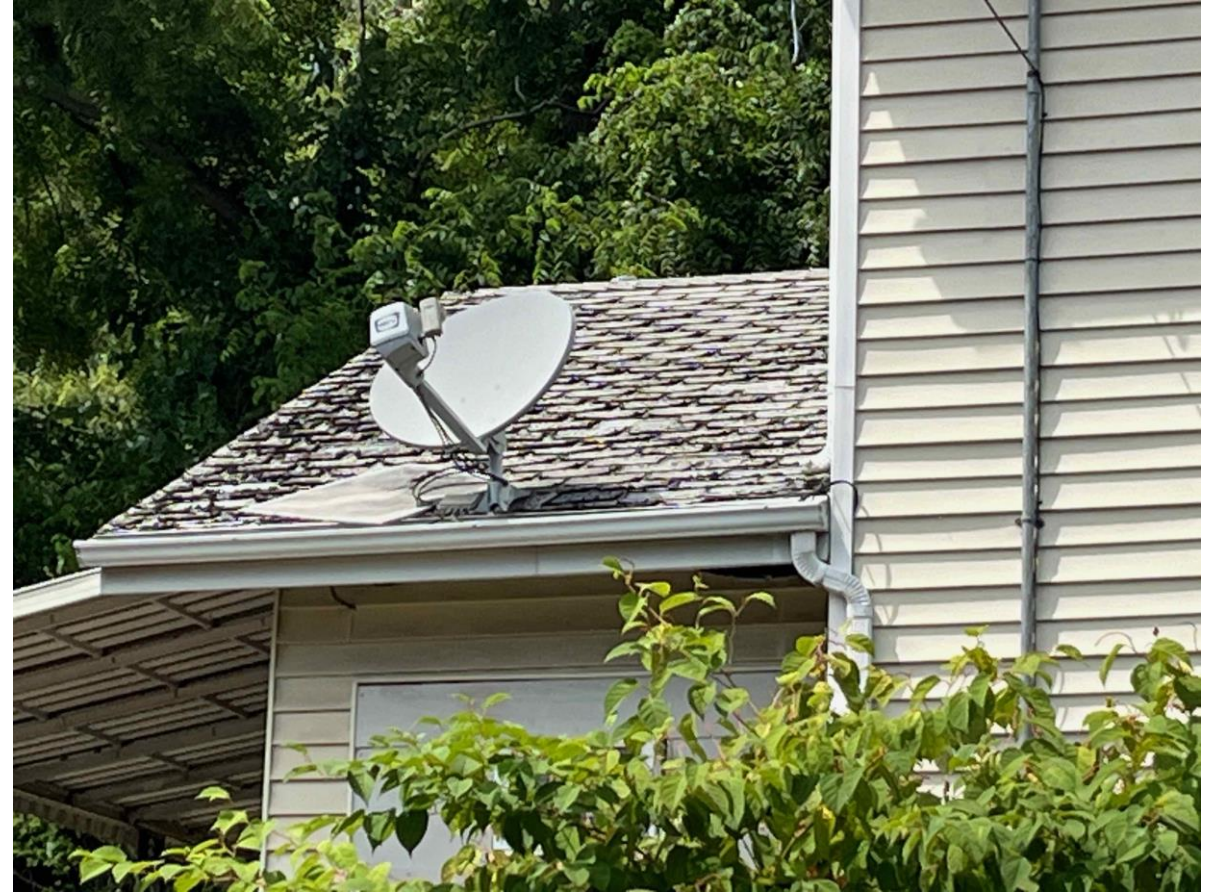
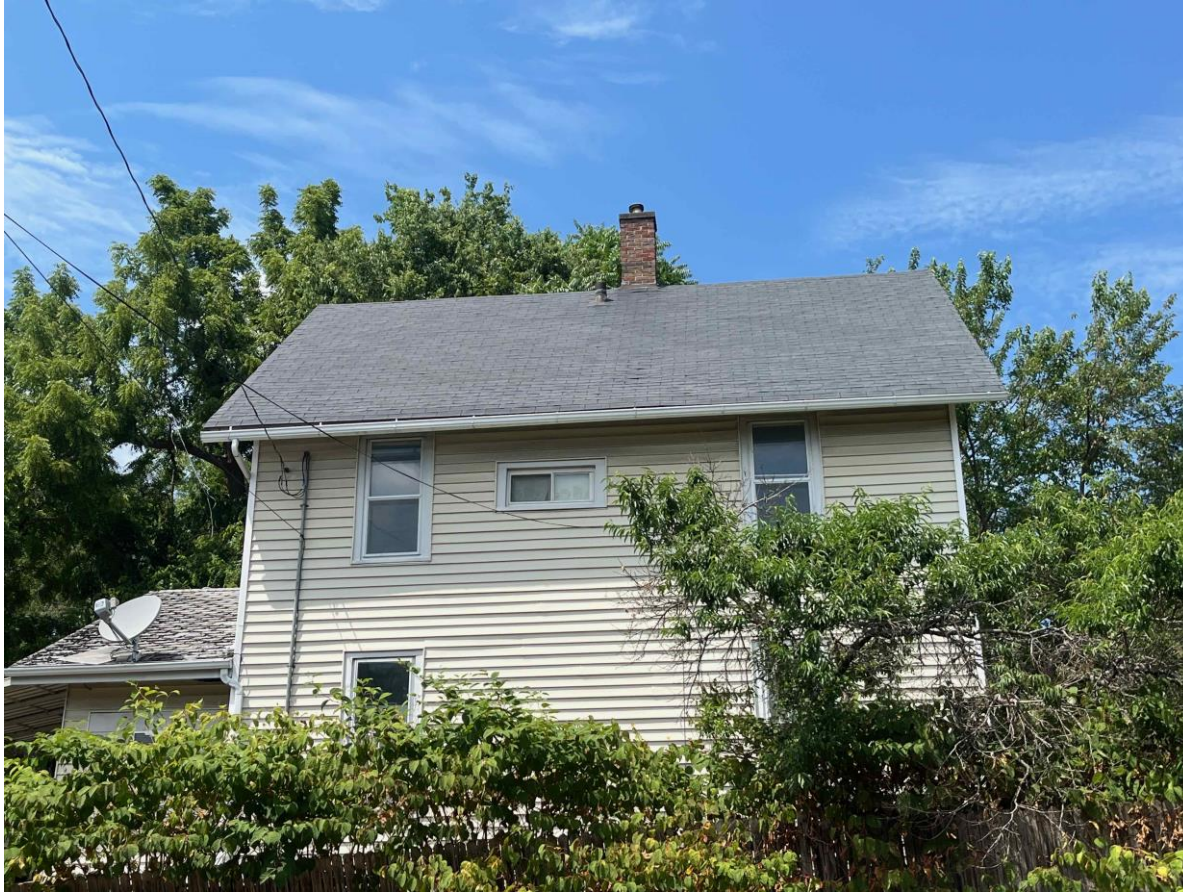
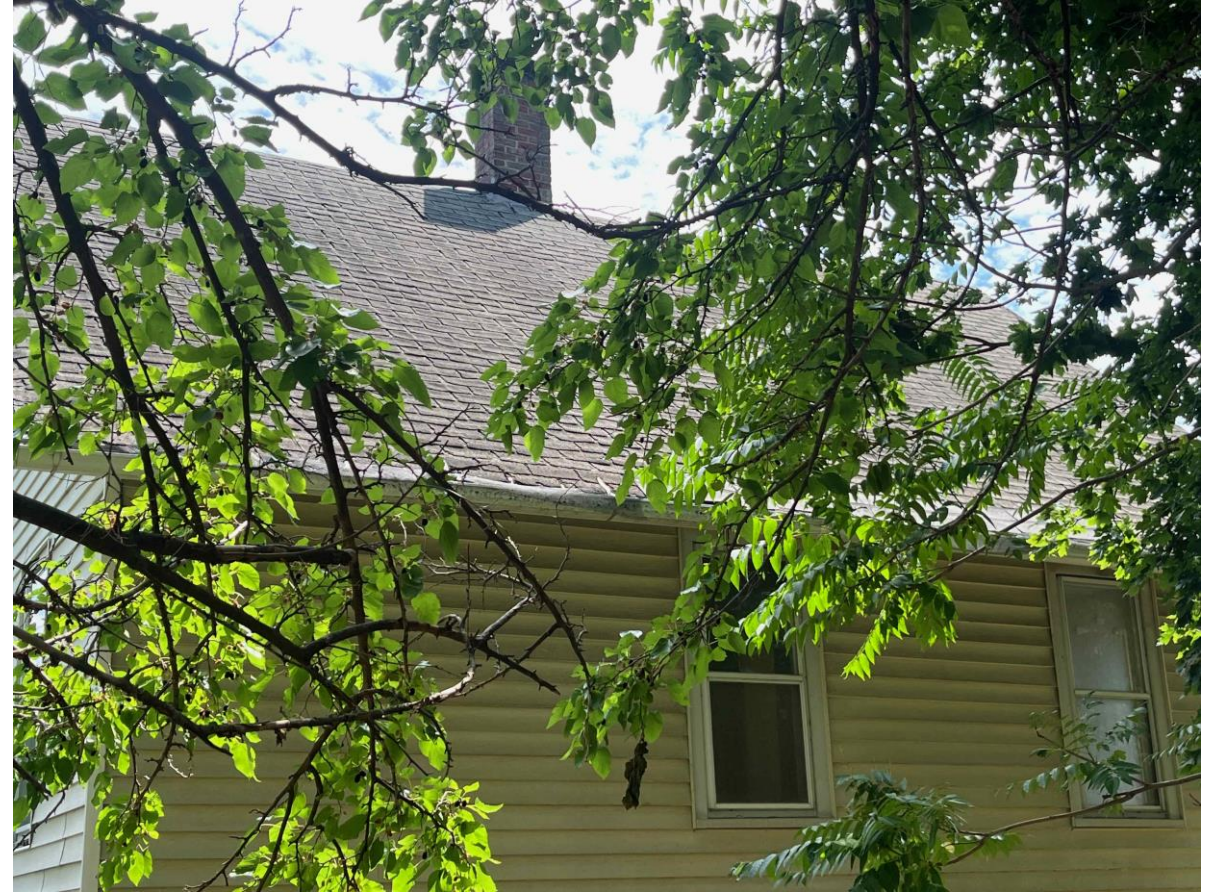
## Main House

# Existing Condition

The historic property inventory sheet identifies the roofing material as asphalt shingle. Based on prior building permits, the existing roof appears to be a 3-tab shingle. The benefits of the proposed architectural shingle include enhanced durability, better wind resistance, improved waterproofing capabilities, and a more dimensional appearance for added curb appeal. Staff consider the installation of an architectural shingle to be a replacement in-kind.

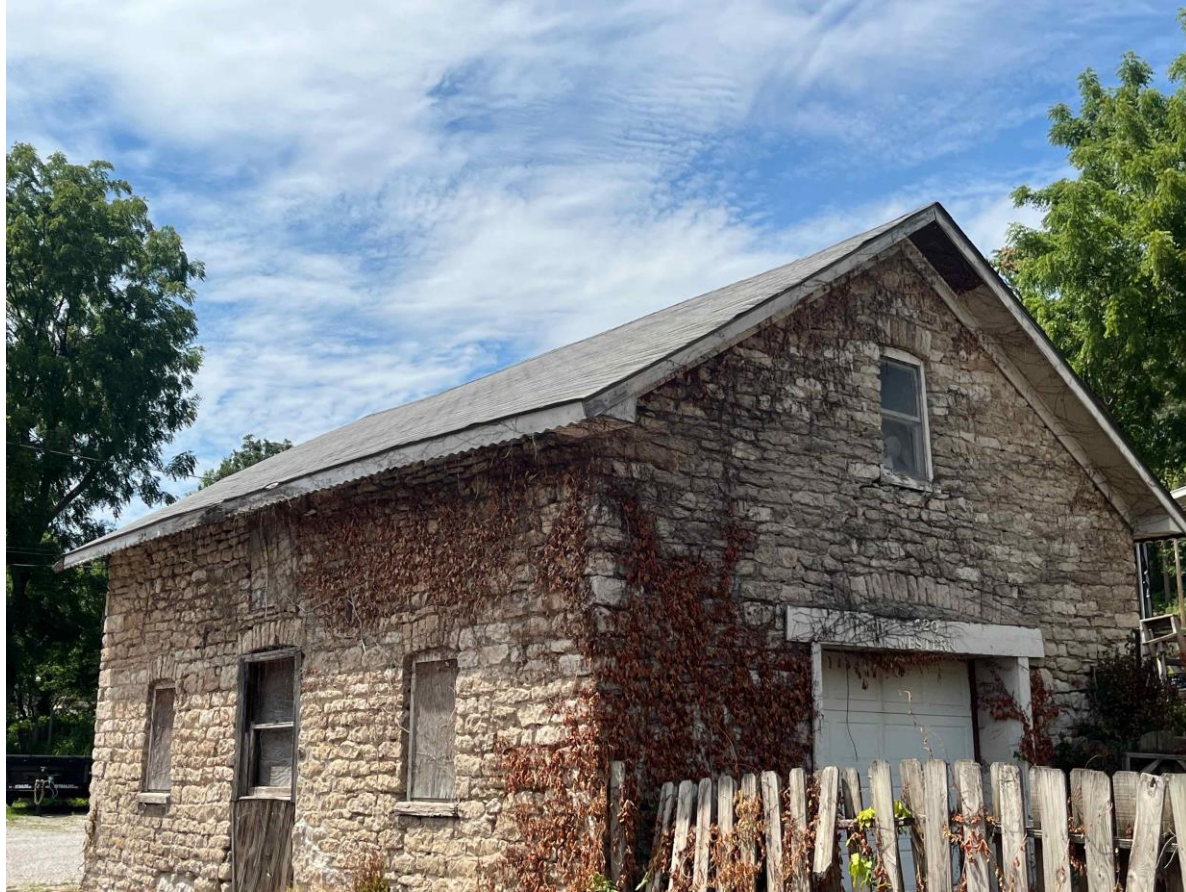
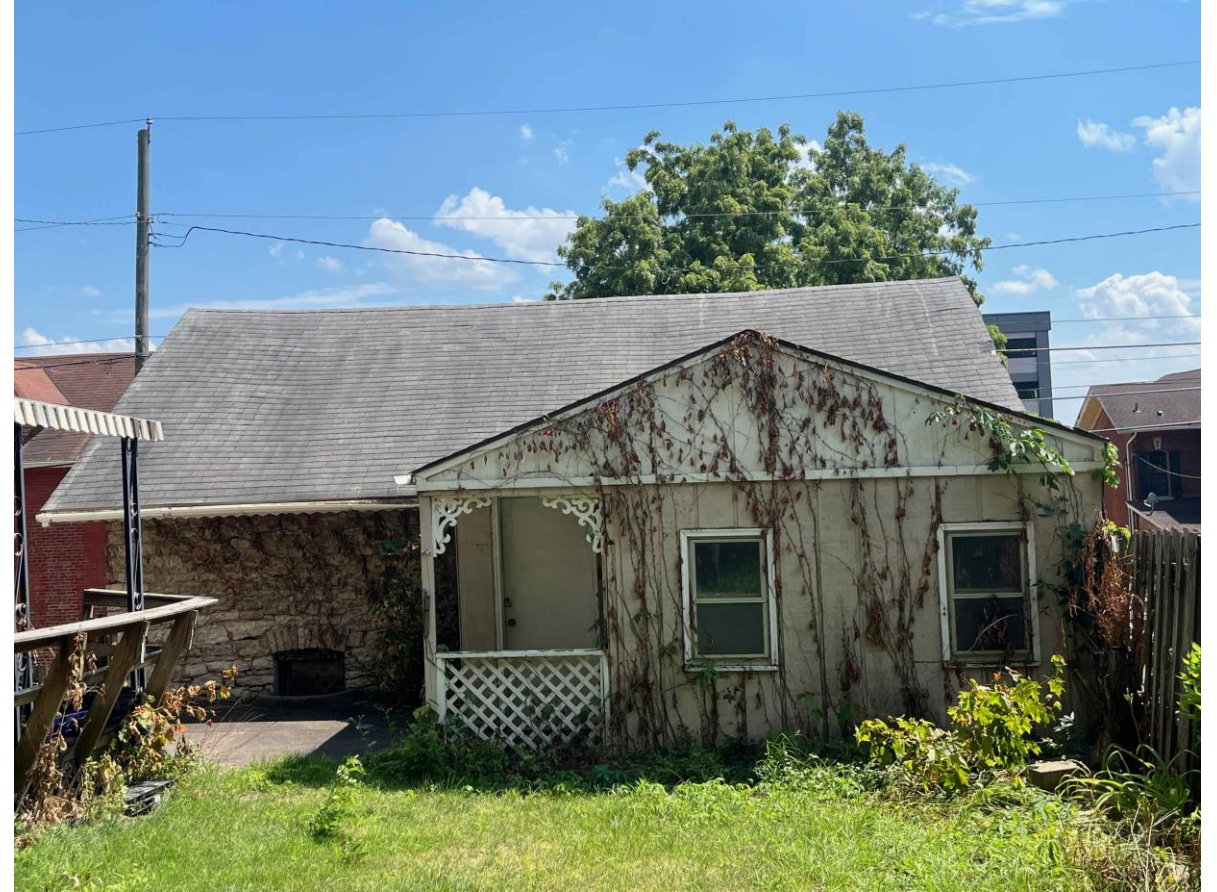
## Stone Carriage House

Currently No Gutters on Alley Facing Roofline.

In addition, the installation of new gutters will keep both structures in a good state of repair by draining water away from the building foundations. It appears the stone carriage house does not have gutters along the alley roof line. Staff believe gutters will keep the property in a good state of repair while having minimal impact on the historic characteristics of the home.

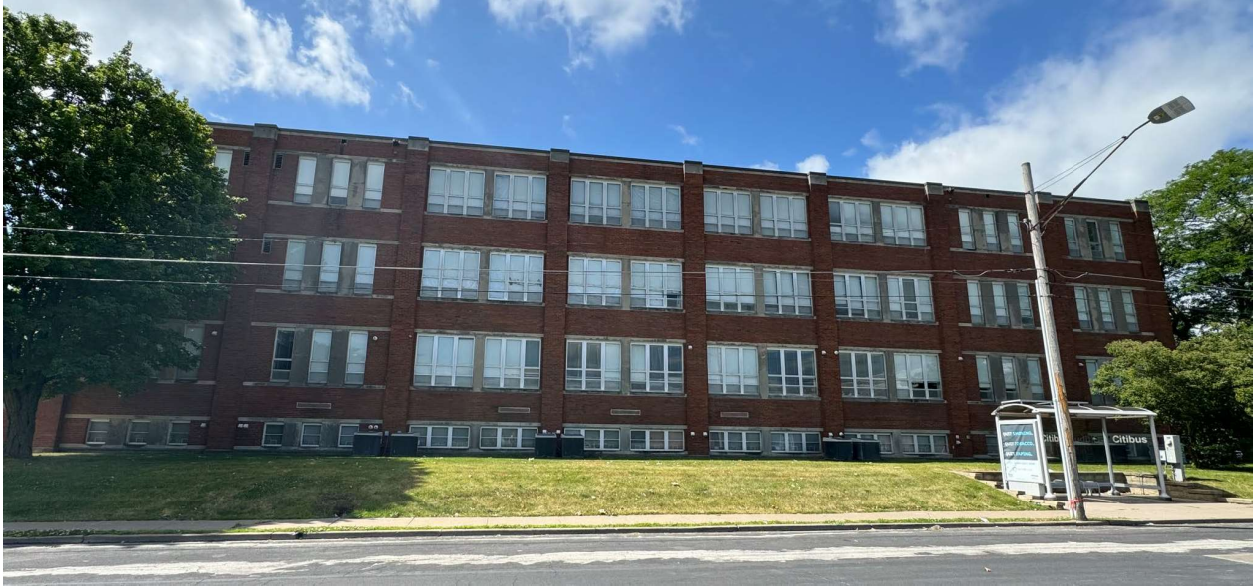
### Walsh Lintels and Caulking

Existing steel lintels on North side of Walsh building will be replaced with steel lintels. These are behind the brick and visually nothing will change. Any lintels replaced the brick will be placed back in. Any caulking will be done white which matches existing/previous caulking. No windows are changing.

The north elevation is a predominant facade given its presence along 12th Street. The brickwork and associated structure surrounding the lintels will be removed to allow access for its replacement. Once the work is completed, the red-brick and concrete will be reinstalled on the facade. If done correctly, there should be minimal visual impact on the exterior of the building. There are no proposed changes to the windows. The proposed scope of work addresses a structural concern identified in the Notice and Order.

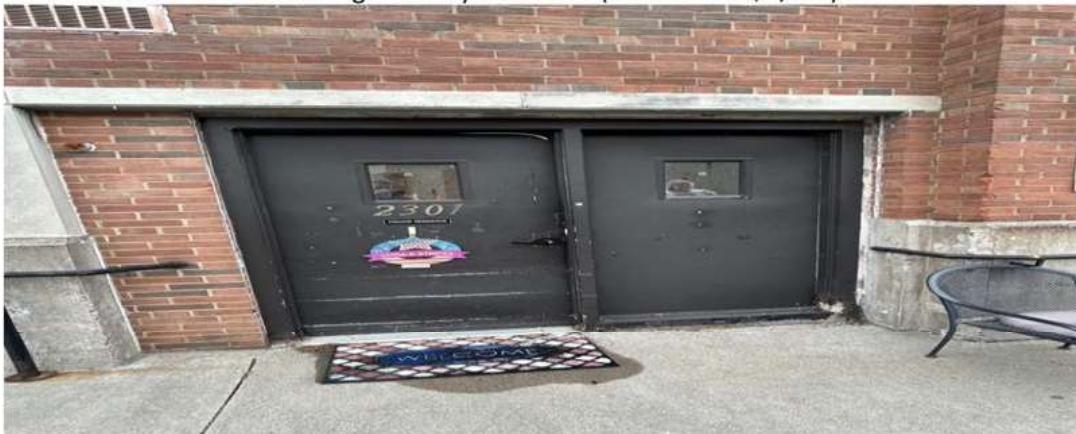
### Door Frame Replacement

The existing steel frame and door will be replaced with a steel frame and door and will be painted to match the current door. The door submittal is attached.

**Scope of work:** Replace steel door on east elevation

- Remove existing door without damaging brick or stone
- Set new door following masonry standards (Door cost is \$4,400).

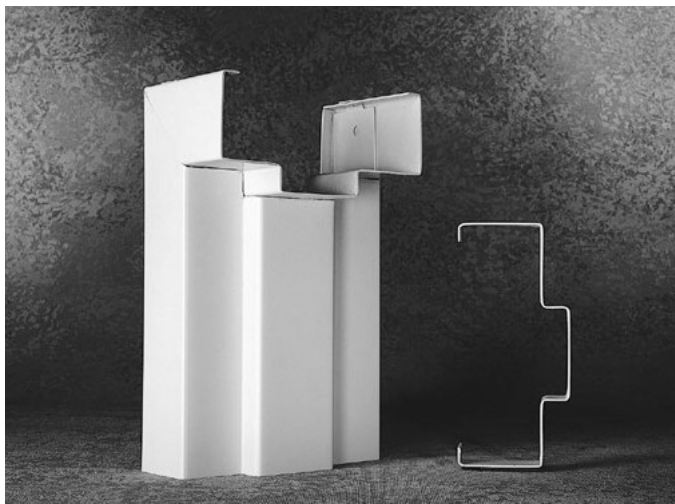
## F Series flush

F Series 3 sided flush frames are designed to meet requirements for light to maximum duty applications in both commercial and institutional buildings. They are installed in both interior and exterior locations, and in virtually all types of buildings and wall constructions. These frames are to be installed as part of the wall framing sequence. They can be specified and supplied as KD (knock-down) for field assembly prior to installation or welded for installation as a complete unit.

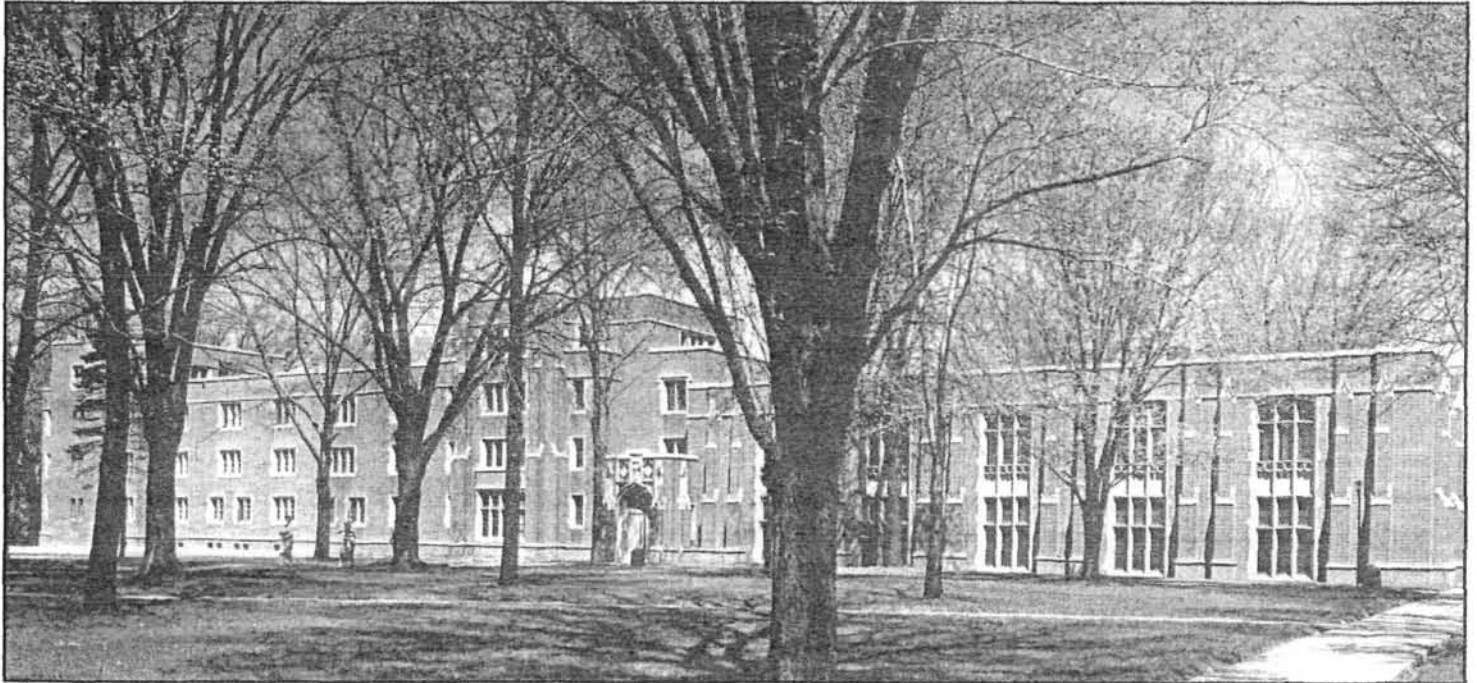
**North Hall-Petersen Hall after construction of west wing, ca. 1955** (historic view looking north; from: Marycrest College Collection. Marycrest College Archives, Congregation of Humility of Mary Center, Davenport, Iowa.)

and coping. Windows throughout the building are metal with true divided lights. Sash include operable casements (in dorm rooms) and variously configured multiple fixed lights.

The asymmetrical front façade is dominated by three principal elements: a four-story tower, a projecting entrance bays, and the fenestration, principally the multi-story windows of the east wing. The first of these elements is understated by most Jacobethan or Collegiate Gothic standards. The tower projects forward from the front façade with brick piers and paired, stone trimmed buttresses set at the corners. The first floor has a shallow bay window with narrow, multi-light casement windows and transoms divided by stone mullions. Upper levels of the tower have four casement windows, each with four lights set in stone frames and divided by stone mullions. The tower extends a full story above the flanking wings.

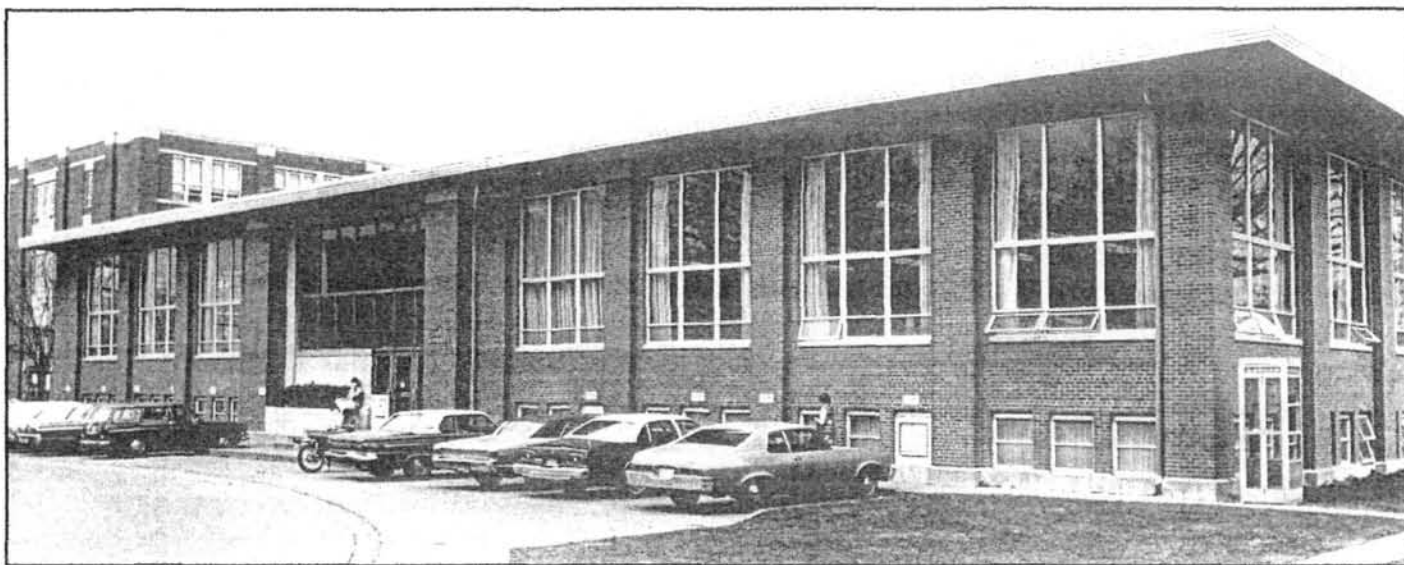
**Cone Library with Walsh Hall in background, ca. 1970** (historic view looking northeast; from: Marycrest College Collection. Marycrest College Archives, Congregation of Humility of Mary Center, Davenport, Iowa.)

The interior spaces of Cone Library are accessed via a split-level entrance foyer located inside the glass entrance bay facing the central campus. The upper or main level of the library has tall ceilings with the front section half of the building divided into three large rooms separated by wood panel and glass panel walls that reflected the window bay configurations. The original periodical reading room was in the north room, the charging desk and card catalog files in the center bay, and the reference reading room in the south bay. The stack area extending across the rear of the building has three levels in the combined main and lower level vertical space. A second set of internal circulation stairs is located in the northeast corner of the building along with offices and a study room. The lower level of the library originally contained the student union or social center in the south half of the building and an audio-visual room and alumnae office, and receiving room in the north half. Interior spaces have painted concrete block and plaster walls, plaster ceilings, and asphalt floor.

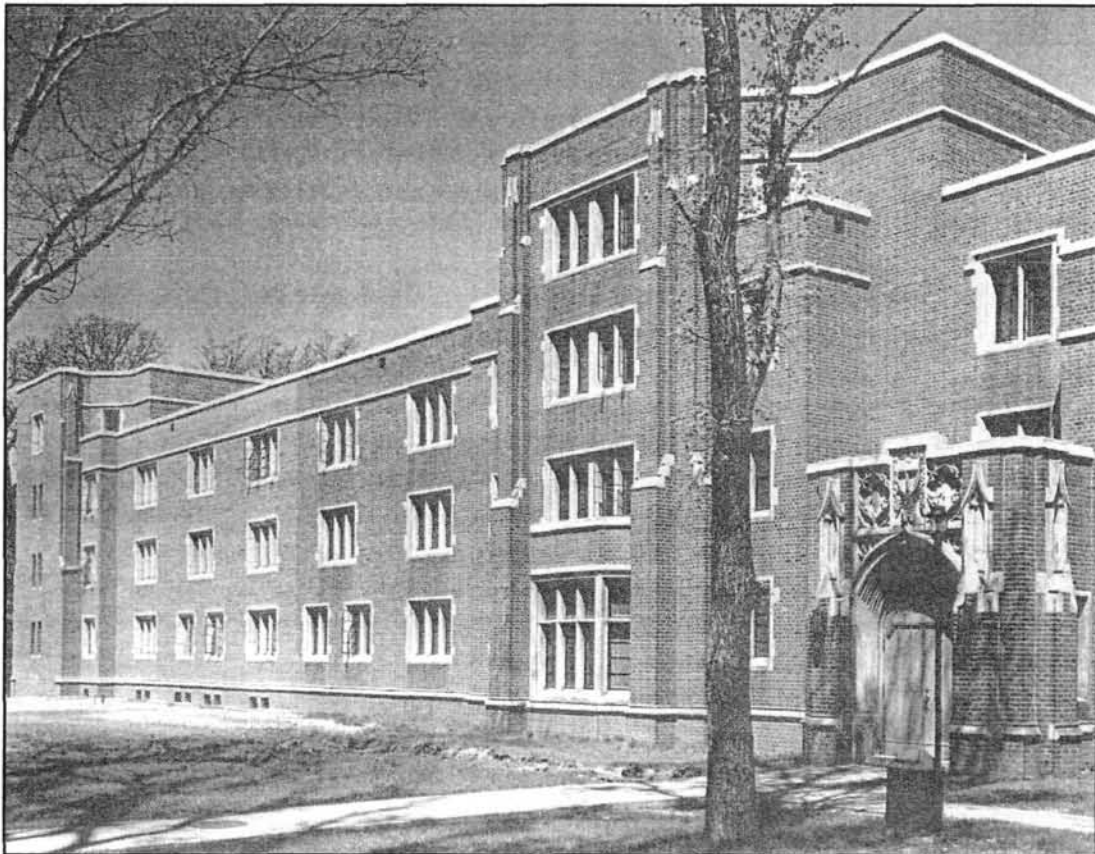
Construction of North or Petersen Hall, Marycrest's second building featuring elements of the Late Gothic Revival and Jacobethan Revival styles, took place over three phases beginning in 1948 with both Temples participating in the first two phases. A third architect practicing with the firm, Raymond C. Whitaker (1892-1972), had joined Seth Temple's firm by the late 1930s. After the deaths of Seth and Arthur, the firm was sold to an out of state firm. Whitaker took up the role of architect for Marycrest College and was responsible for the third phase of Petersen Hall completed in 1962. By the time this building was completed it would be the most architecturally elaborate design on the Marycrest College campus with a rich pallet of surface treatments, window forms, stone ornamentation, Gothic entrance shapes, and interior Gothic elements. The completed building has a strong horizontal form but features several jutting towers that when combined with the campus's tree covered vistas, gives the building a picturesque appearance.

***North Hall-Petersen Hall shortly after construction of west wing; note wall joint, 1951*** (Looking northwest; from: "Marycrest College, 1939-1959," Davenport, Iowa: Marycrest College, 1959)

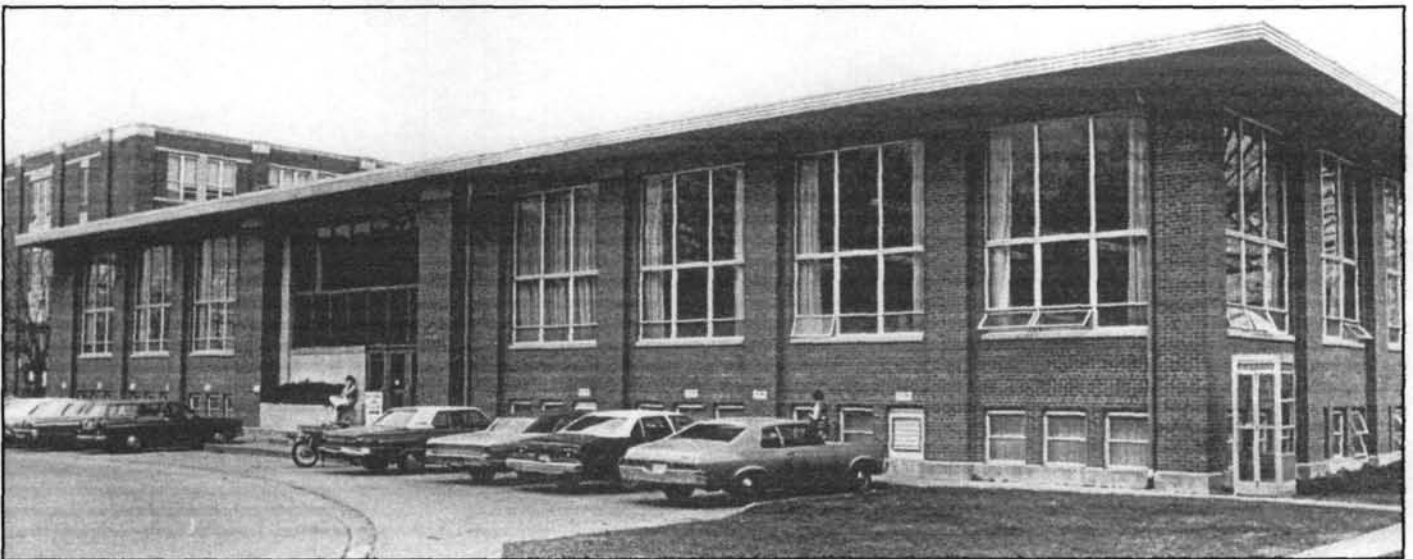
The only changes to the Cone Library since the Marycrest College Historic District was originally nominated in 2005 are a result of the commencement of work on the building's interior for its reuse as apartments and meeting room space. The exterior has been maintained but some sections of wood trim are showing deterioration. The current work is being undertaken under the guidance of the staff of the State Historical Society of Iowa and the National Park Service. Its completion will make it the 5<sup>th</sup> contributing resource in the district to be reused as senior housing and activity space since the current owner commenced work on the former college campus in 2005. Historic Preservation Certification Applications, Part I and Part II for the Cone Library have been filed with the State Historical Society and review is pending.

**Cone Library with Walsh Hall in background, ca. 1970** (historic view looking northeast; from: Marycrest College Collection. Marycrest College Archives, Congregation of Humility of Mary Center, Davenport, Iowa.)

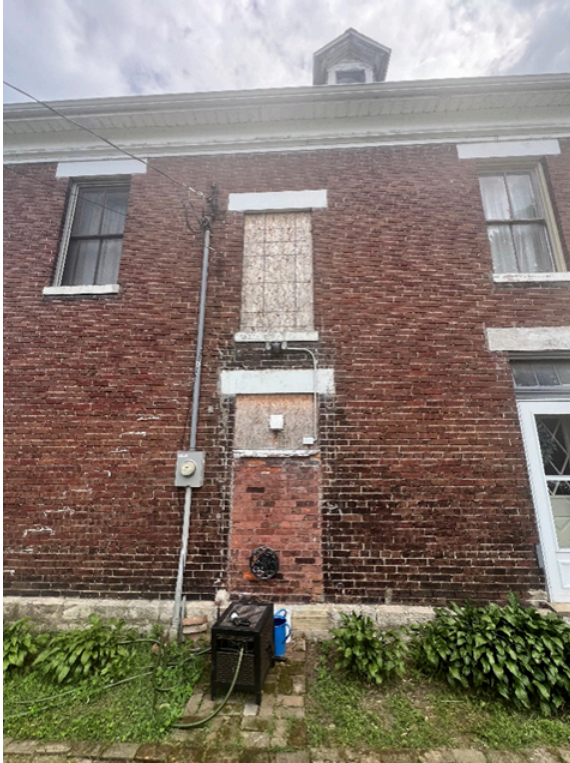
Exterior view of boarded window from alley

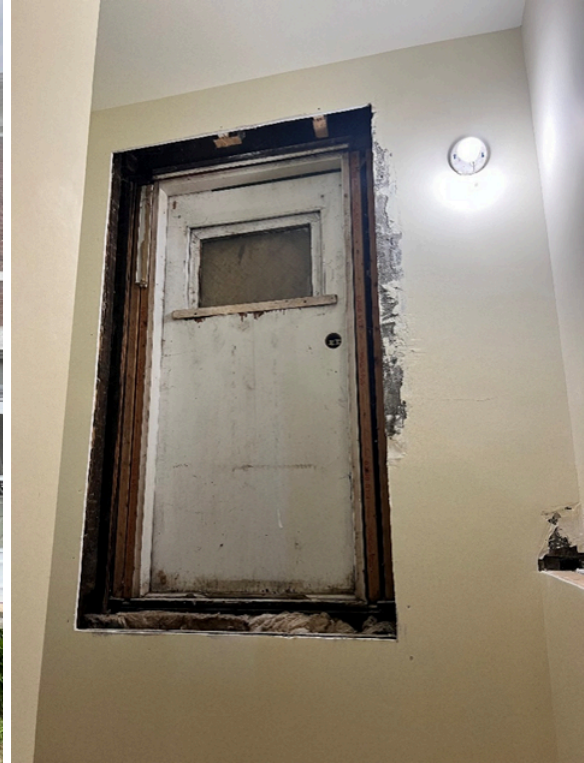
Interior photo of window on back staircase landing

The proposed window will have the same grid pattern as the two other windows on the second floor of the house on either side, a double hung cottage style with one vertical trim piece on both the upper and lower window. The material for the proposed window will be vinyl. We have contacted several window companies to quote wood windows that are similar to the current ones and have been unable to find a company that could make wood, especially with this custom size. The color of the vinyl would be a textured matte coal black. The limewash header and footer of the window will remain intact.

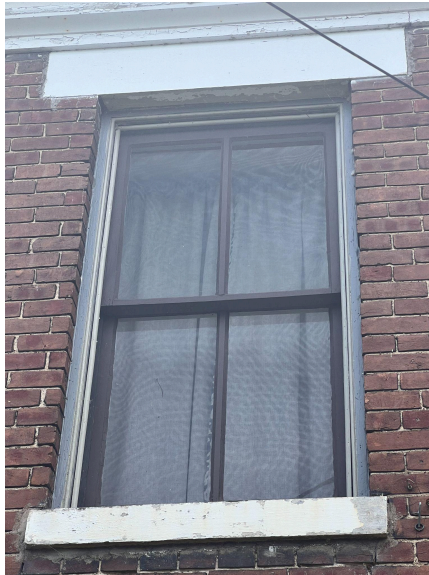
Example of the other two exterior windows on the back of the home  
above and on either side of the window to be replaced

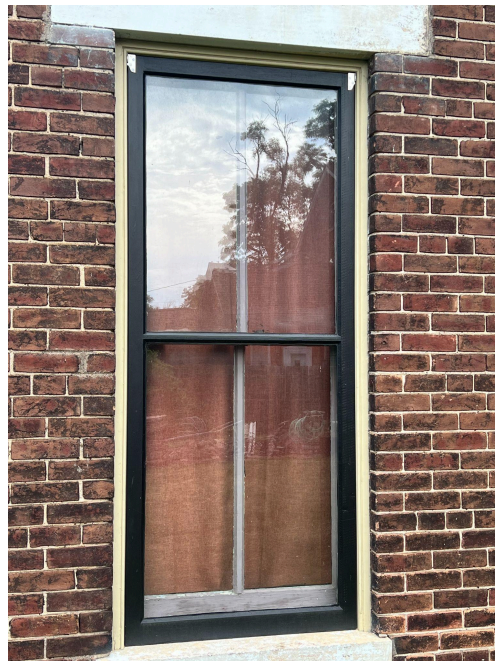
Wood-framed storm window in kitchen to be placed over replacement window
