# HISTORIC PRESERVATION COMMISSION MEETING

CITY OF DAVENPORT, IOWA

Tuesday, September 10, 2024; 5:00 PM

1. Case COA24-16: Request for the installation of a new roof at 628 Ripley Street. The William H. and Emma A. Ruser House is located within the Hamburg Local Landmark Historic District. David LaRoque, petitioner. [Ward 3]
2. Case COA24-17: Request for the installation of a new roof at 709 Brown Street. The William H. Wiese Residence is located within the Hamburg Local Landmark Historic District. Dawn Santiago, petitioner. [Ward 3]
3. Case DNRHP24-01: Request for demolition of the detached garage at 739 Perry Street. The Roslyn Flats is individually listed on the National Register of Historic Places. Palmer College Foundation, petitioner. [Ward 3]

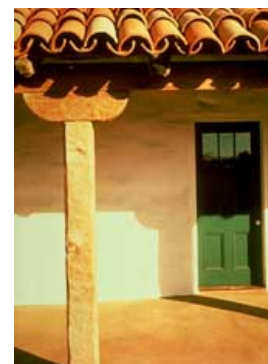
Tapered barrel clay roof tiles were custom made for the restoration of the 1820s Indian barracks at Mission Santa Cruz in California. Photo: NPS files.

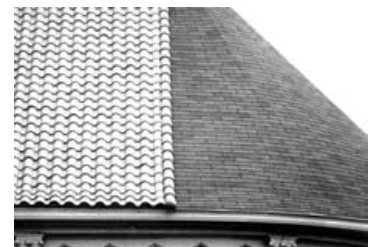
Asphalt shingles are an incompatible replacement substitute for the original Spanish clay tiles. Photo: NPS files.

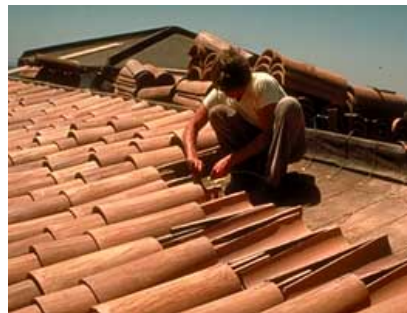
These tapered barrel clay tiles were accurately reproduced from archeological materials found on site. Photo: NPS files.

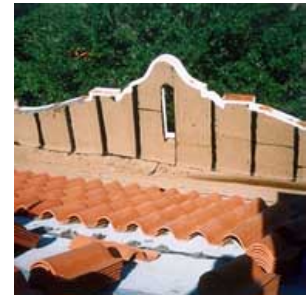
Projections on the underside of these replacement Spanish clay tiles help them adhere to the cement mortar on the roof sheathing. Photo: NPS files.

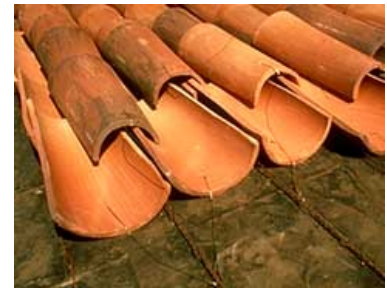
A special system consisting of brass or copper wires is used to attach these tapered barrel roof tiles. Photo: NPS files.
