# HISTORIC PRESERVATION COMMISSION MEETING

CITY OF DAVENPORT, IOWA

# **HISTORIC PRESERVATION COMMISSION MEETING MINUTES**

#### **1. Case COA24-16: Request for the installation of a new roof at 628 Ripley Street. The William H. and Emma A. Ruser House is located within the Hamburg Local Landmark Historic District. David LaRoque, petitioner. [Ward 3]**

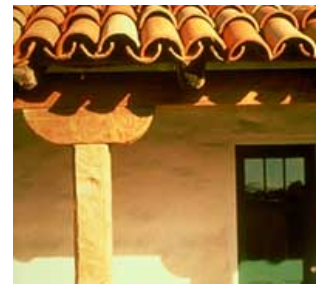
Historic clay tile roof. Photo: NPS files.

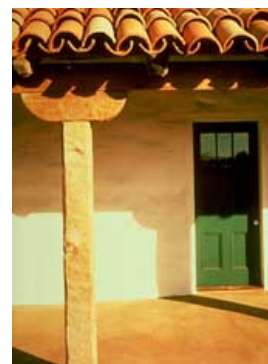
Tapered barrel clay roof tiles were custom made for the restoration of the 1820s Indian barracks at Mission Santa Cruz in California. Photo: NPS files.

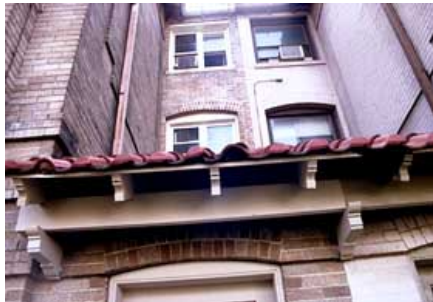
An eave closure or *birdstop* to keep out birds is notably absent from the replacement tile in the center of the bottom row. Photo: NPS files.

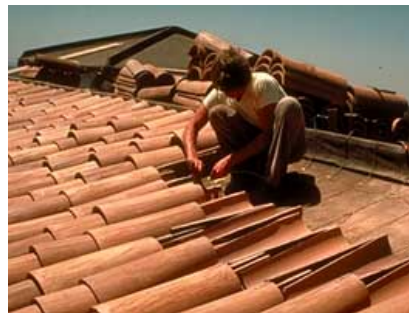
These tapered barrel clay tiles were accurately reproduced from archeological materials found on site. Photo: NPS files.

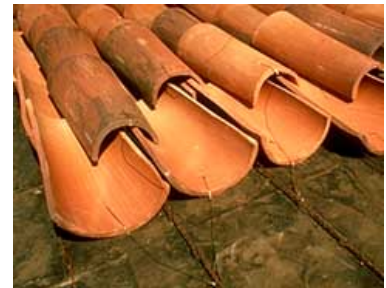
A special system consisting of brass or copper wires is used to attach these tapered barrel roof tiles. Photo: NPS files.

very fragile and easily broken. By using sheets of plywood, planks, or burlap bags filled with sand to distribute weight, the professional roofer can move about the roof to fix broken tiles or flashing without causing additional damage. Another method involves hooking a ladder on the ridge to support and evenly distribute the weight of the roofer.
