# HISTORIC PRESERVATION COMMISSION MEETING

CITY OF DAVENPORT, IOWA

TUESDAY, JANUARY 10, 2023; 5:00 PM

- A. Case COA23-01: Request for exterior alteration at 624 West 5th Street. The Charles and Amelia (Ruch) McElroy House is located within the Hamburg Local Landmark Historic District. Duane Timm, petitioner. [Ward 3]

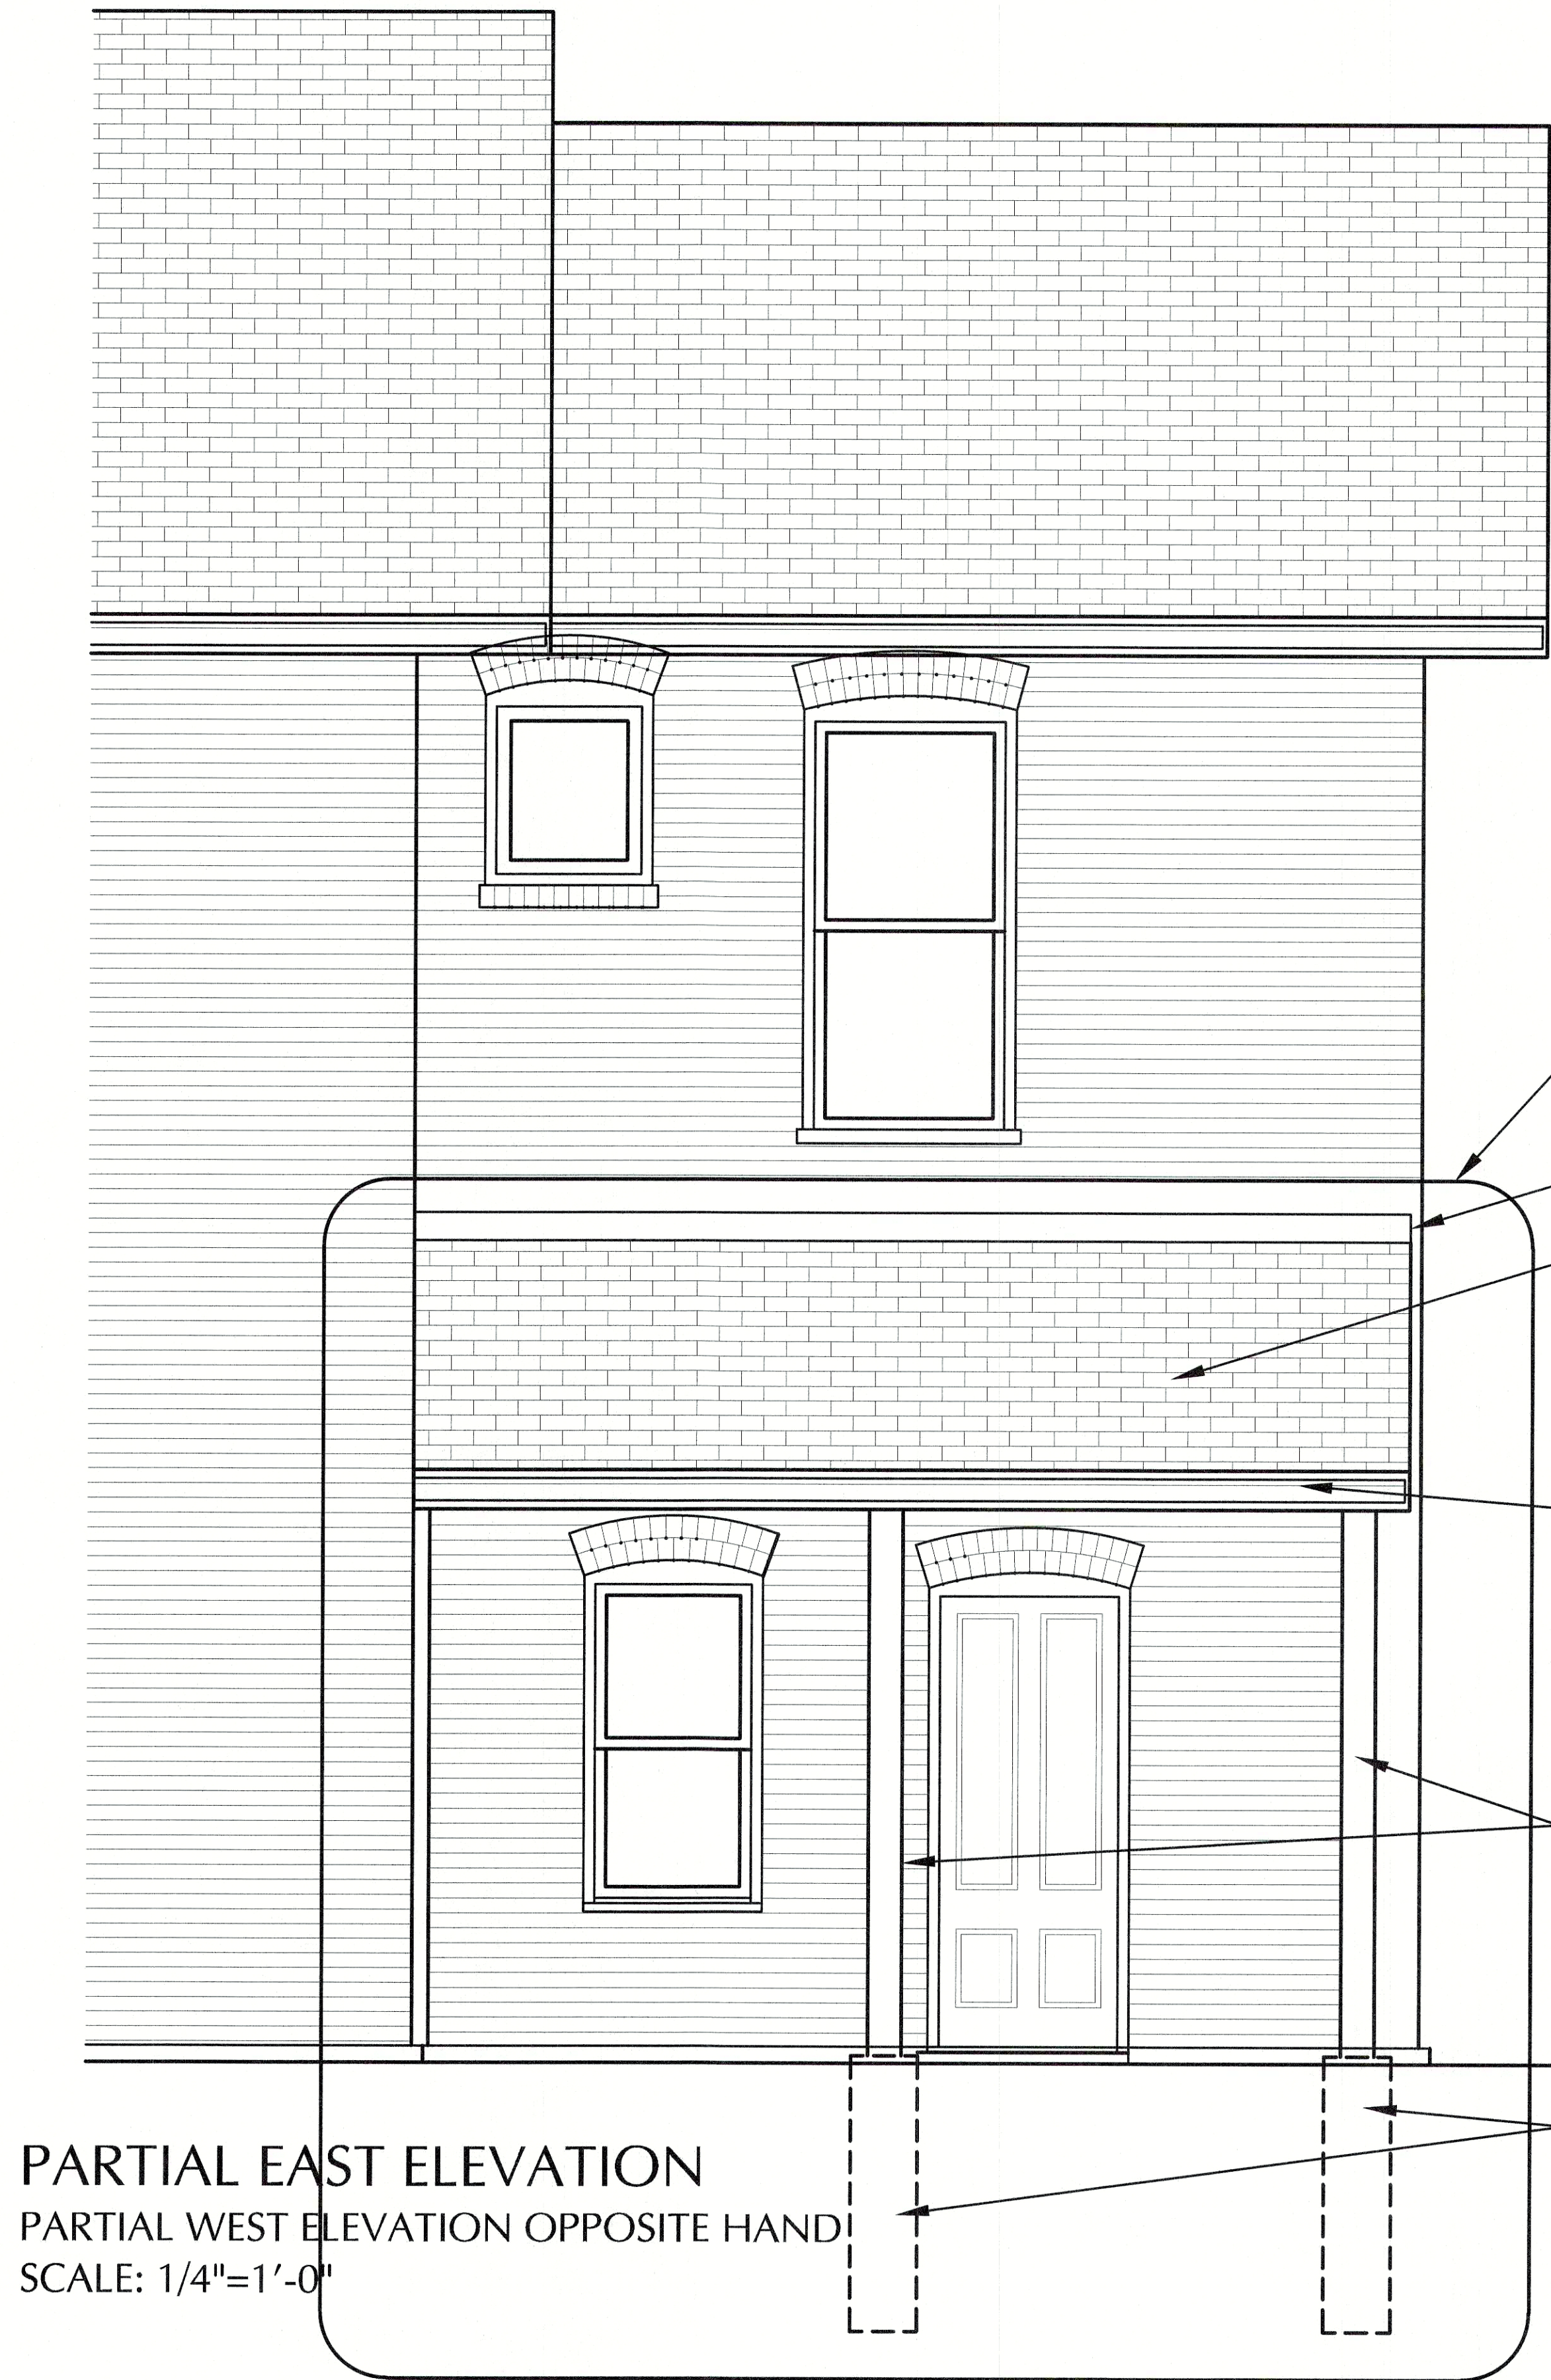
PARTIAL EAST ELEVATION  
PARTIAL WEST ELEVATION OPPOSITE HAND  
SCALE: 1/4"=1'-0"

- NEW PORCH
- FLASHING/COUNTERFLASHING (COPPER)
- ASPHALT SHINGLES (TO MATCH EXISTING)  
ON 15# ROOFING FELT ON 3/4" EXT  
GRADE PLYWOOD ON 2X6 FRAMING @  
24" OC
- PREFINISHED MTL GUTTER & DOWNSPOUTS  
(TO MATCH PROFILE AND COLOR OF EXISTING)  
ON WOOD FASCIA BOARD (PAINT)
- 1X6 WOOD RAKE TRIM (PAINT)
- VERTICAL WOOD SIDING (PAINT)
- 6X6 WOOD COLUMNS - COVER WITH PREFINISHED  
METAL
- 12" DIAM X 48" DEEP CONC POSTHOLE FOOTINGS

- New concrete footing and foundation wall will be poured to create the base of the porch. The deck will be constructed with composite 6 inch wide plank floor on 2x6 treated wood joists.

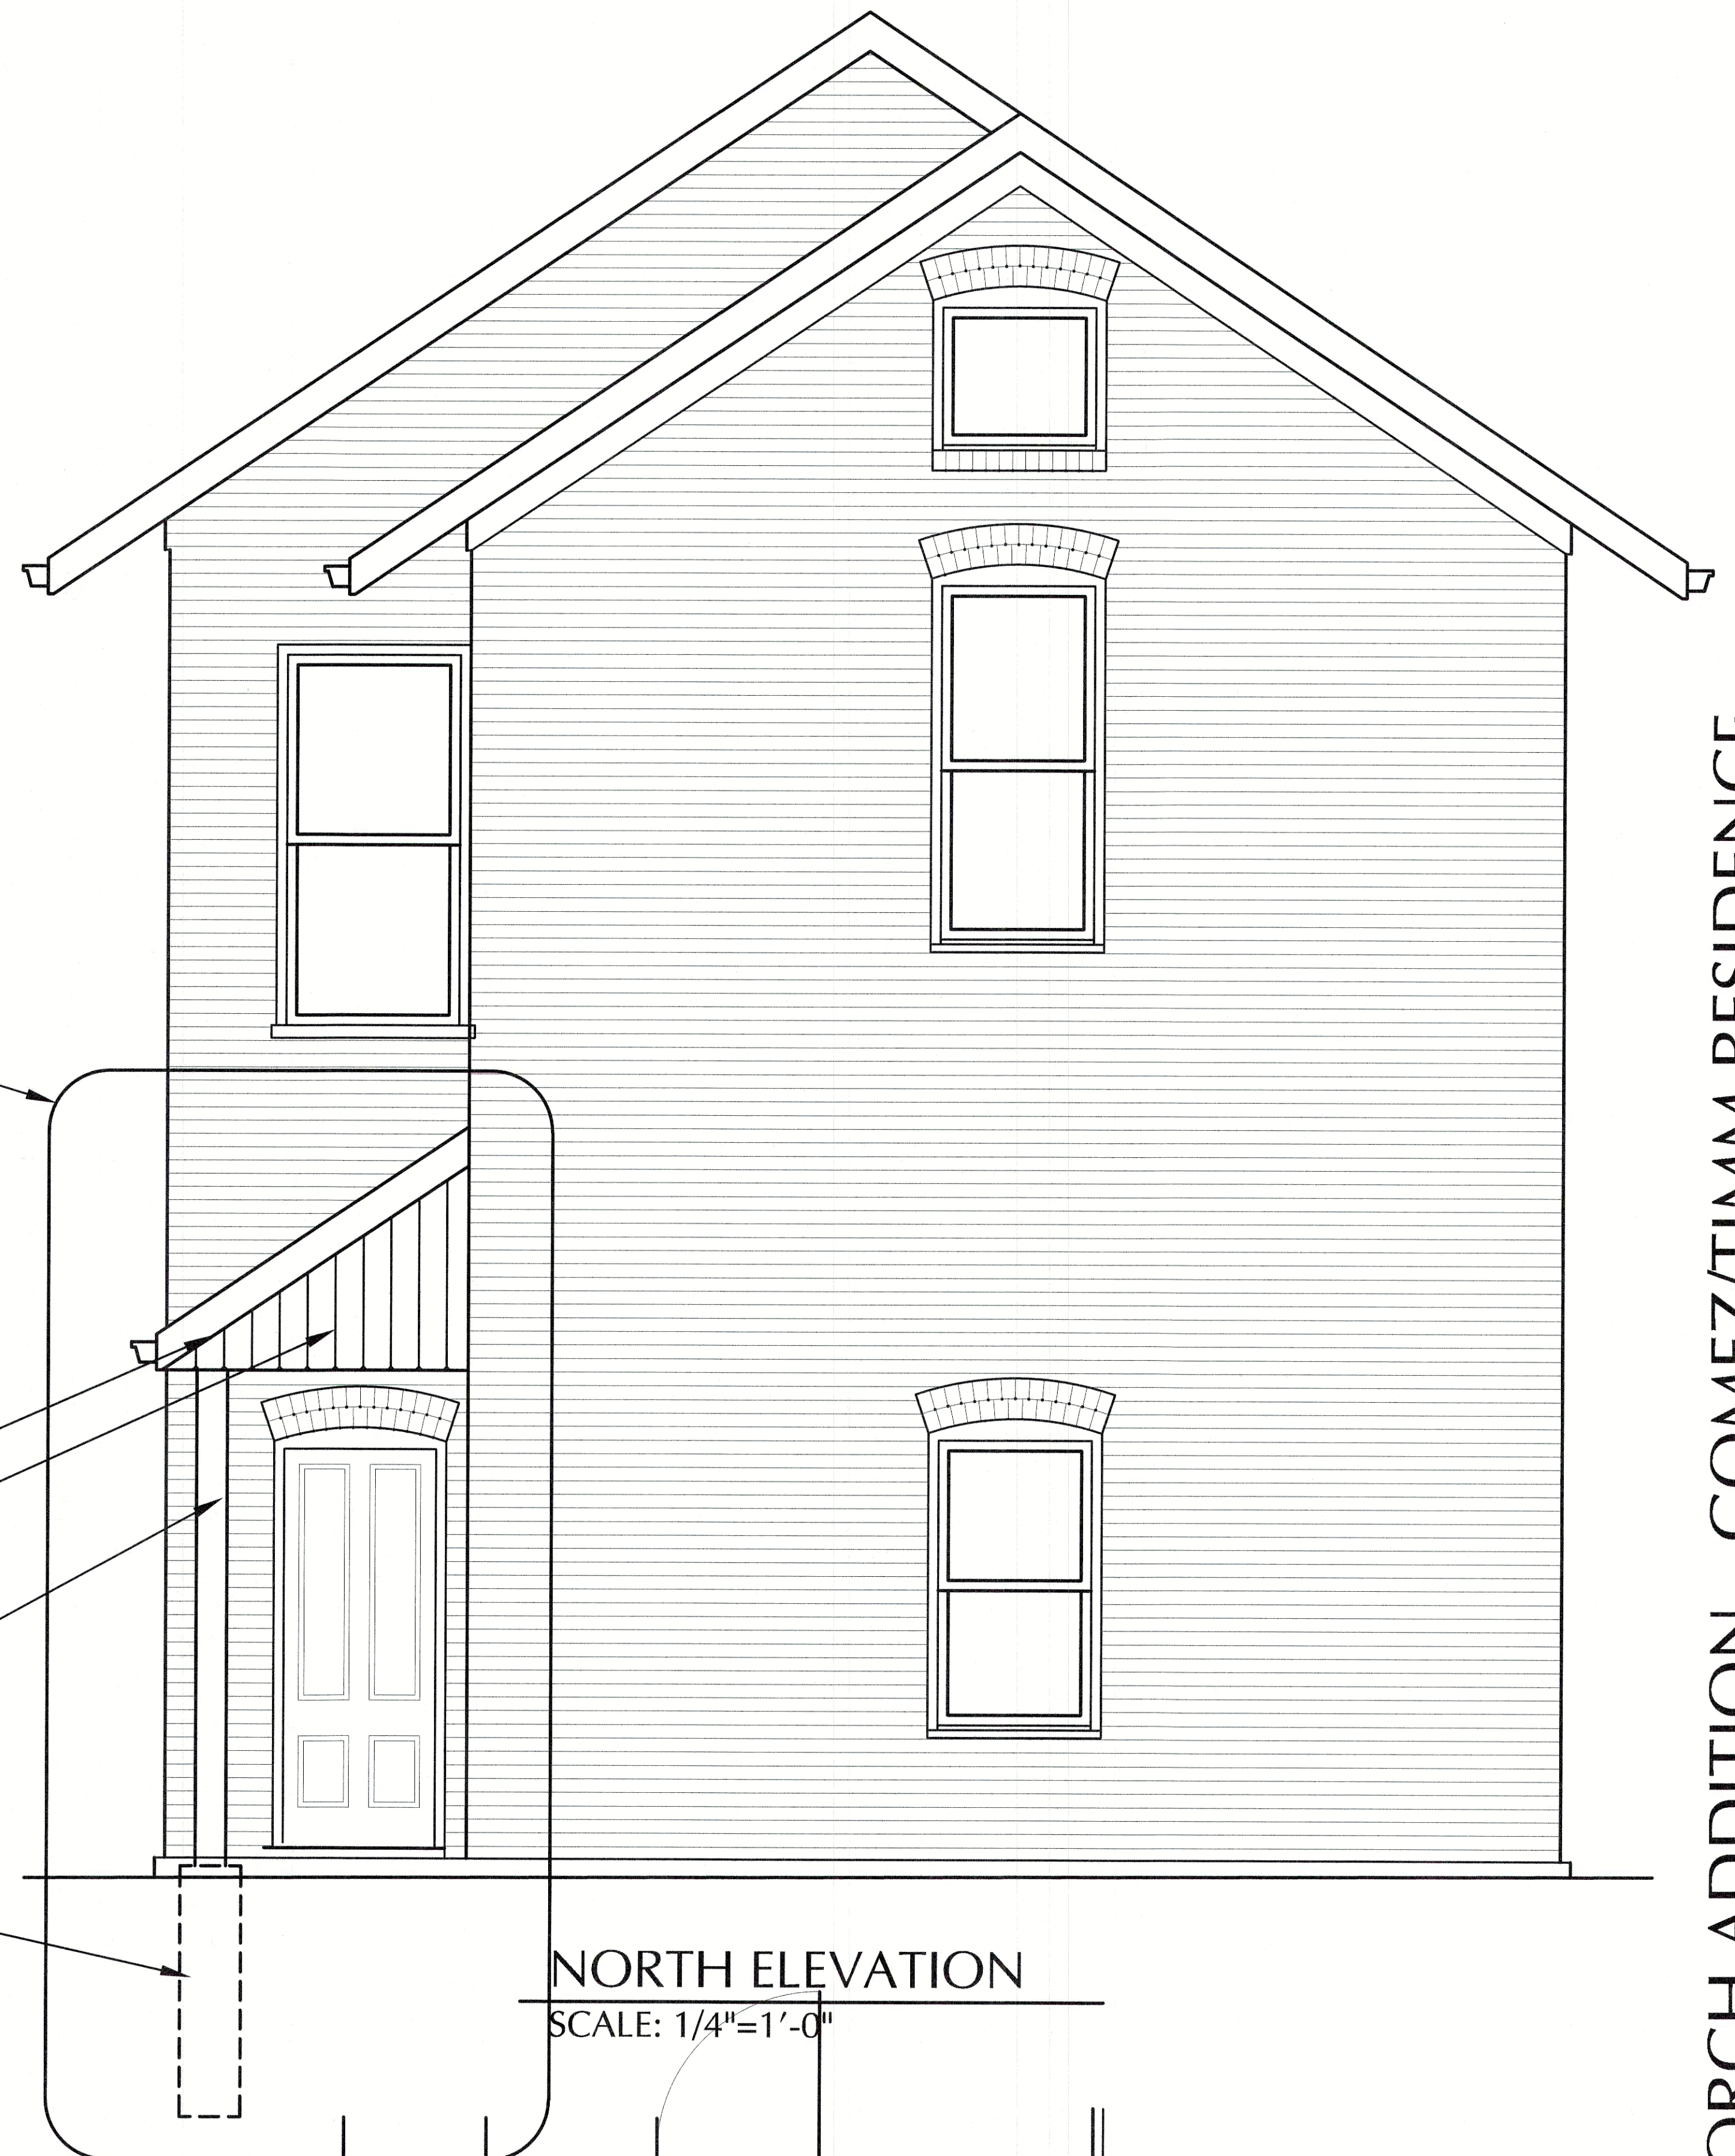
NORTH ELEVATION  
SCALE: 1/4"=1'-0"

FLOOR PLAN  
SCALE: 1/4"=1'-0"

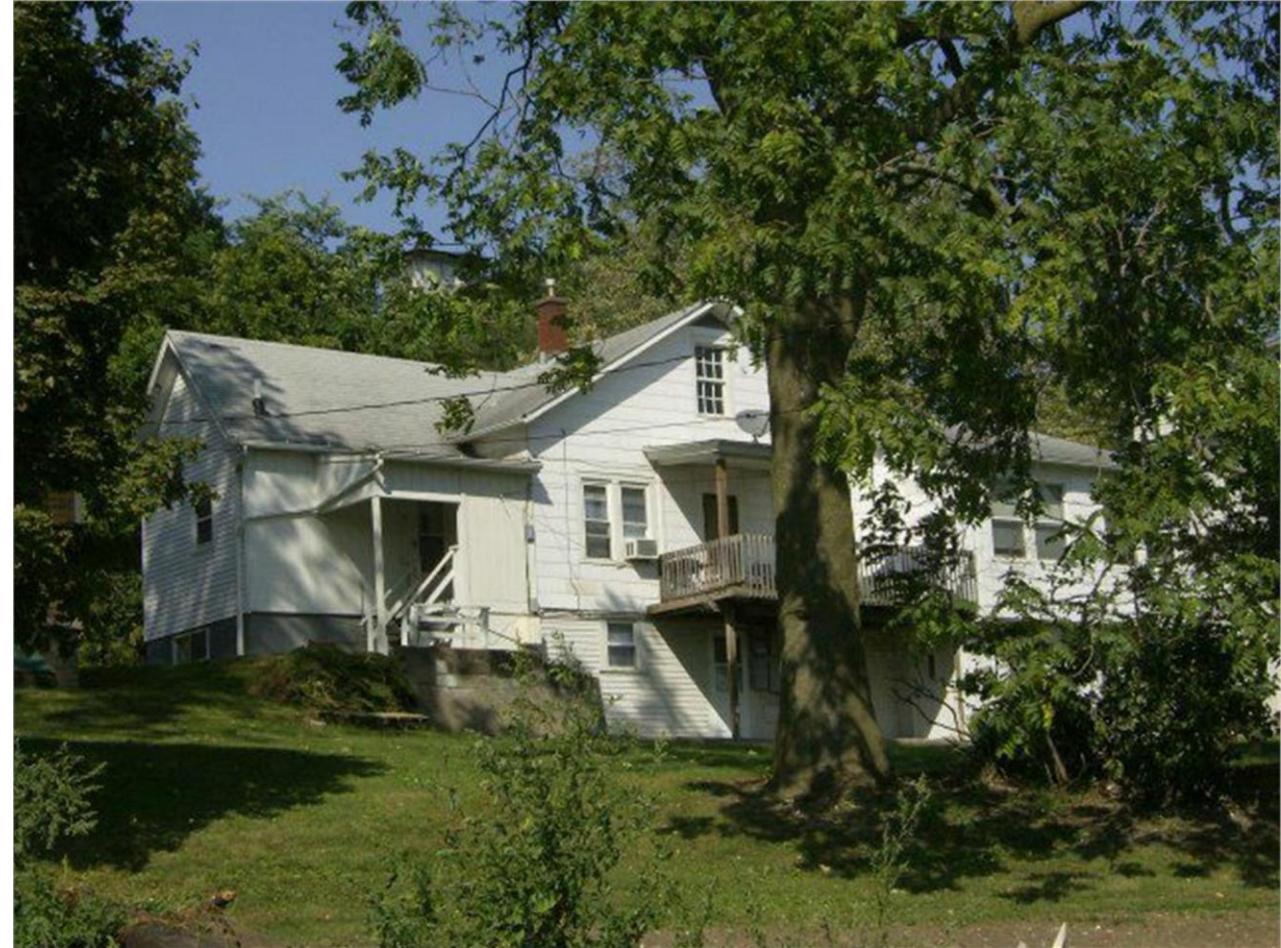
# Soffit & Fascia

- Mismatch of Soffit and Fascia Materials: Wood & Aluminum
- Sections of the building have aluminum wrap, while the original structure appears to have wood.
- While the installation of aluminum soffit and fascia will bring uniformity to the structure, a wood or engineered wood product may be more appropriate with the character of the district.

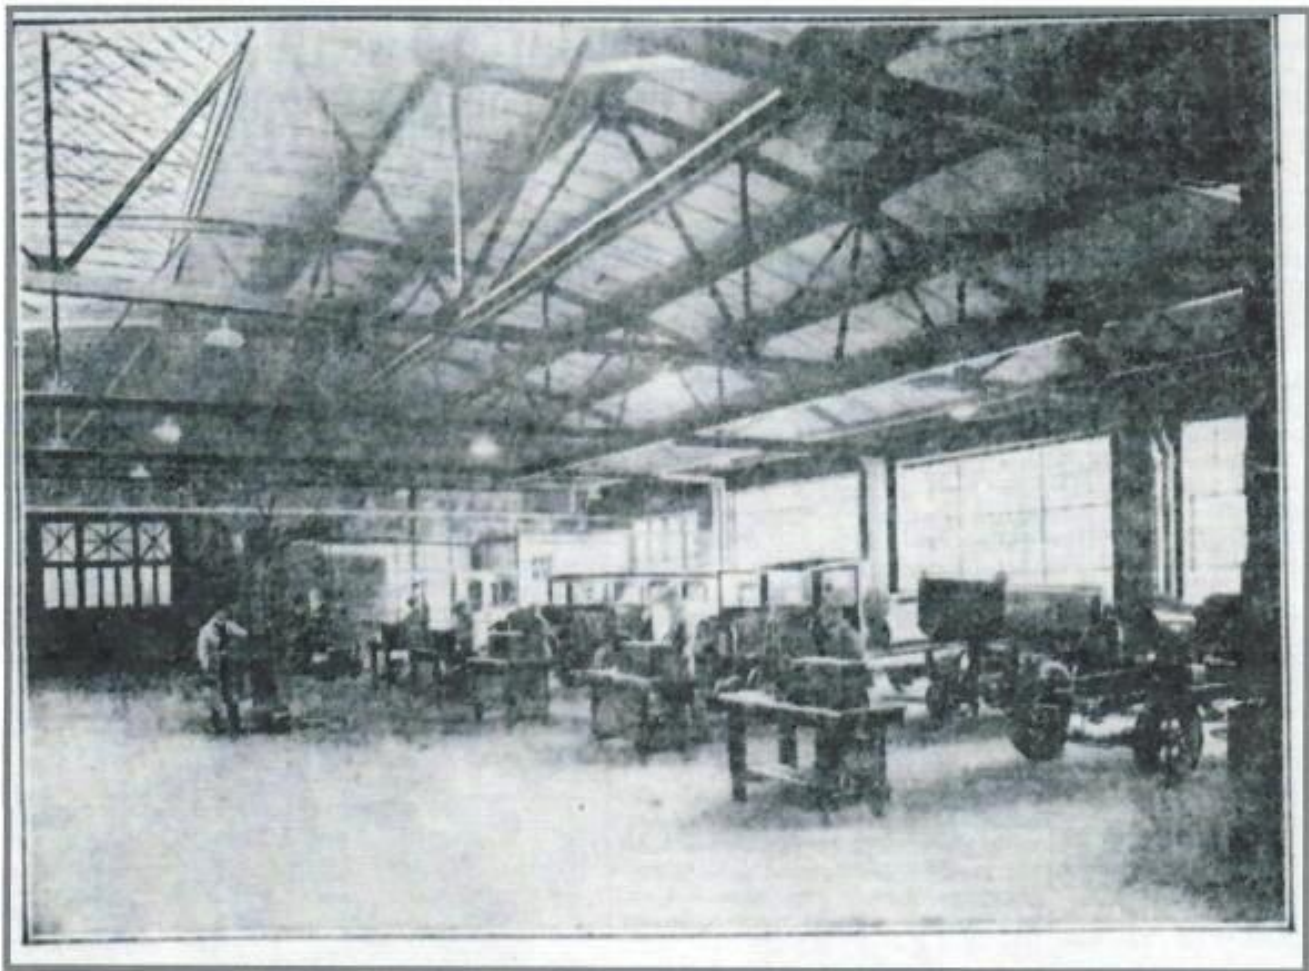
Figure 6

Looking to the northeast, this historic photograph pictures the soaring expanse of the bowstring truss ceiling and the orderly arrangement of workstations in the newly opened International Harvester Truck Sales and Service Station. The main skylight in the ceiling is visible in the upper left-hand corner, its lighter color and gabled configuration differentiated from the rest of the darker plaster-clad ceiling. Some of the building's thirty, 200-watt light fixtures hang from the trusses. Abundant natural light pours in through the steel, industrial windows facing the east and Western Avenue.

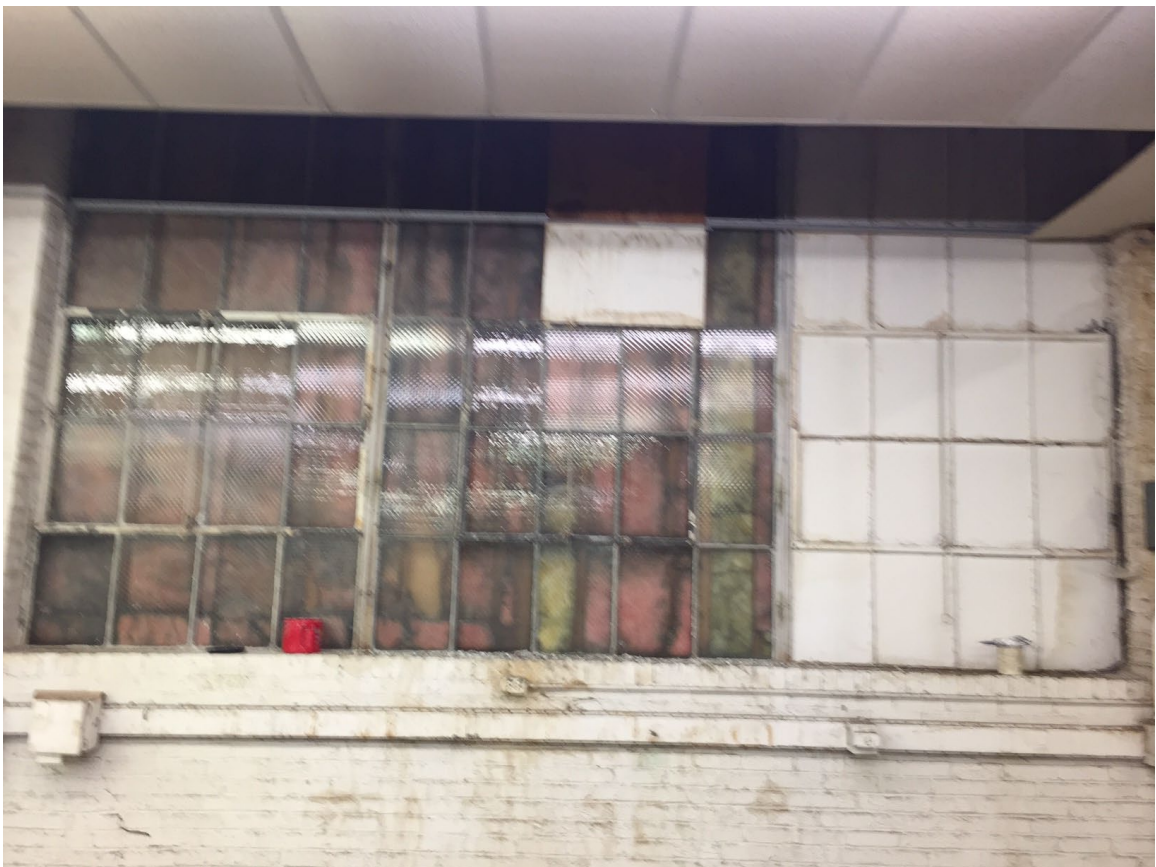
Photo #20. Typical commercial style window looking E, shot 04-14-20.

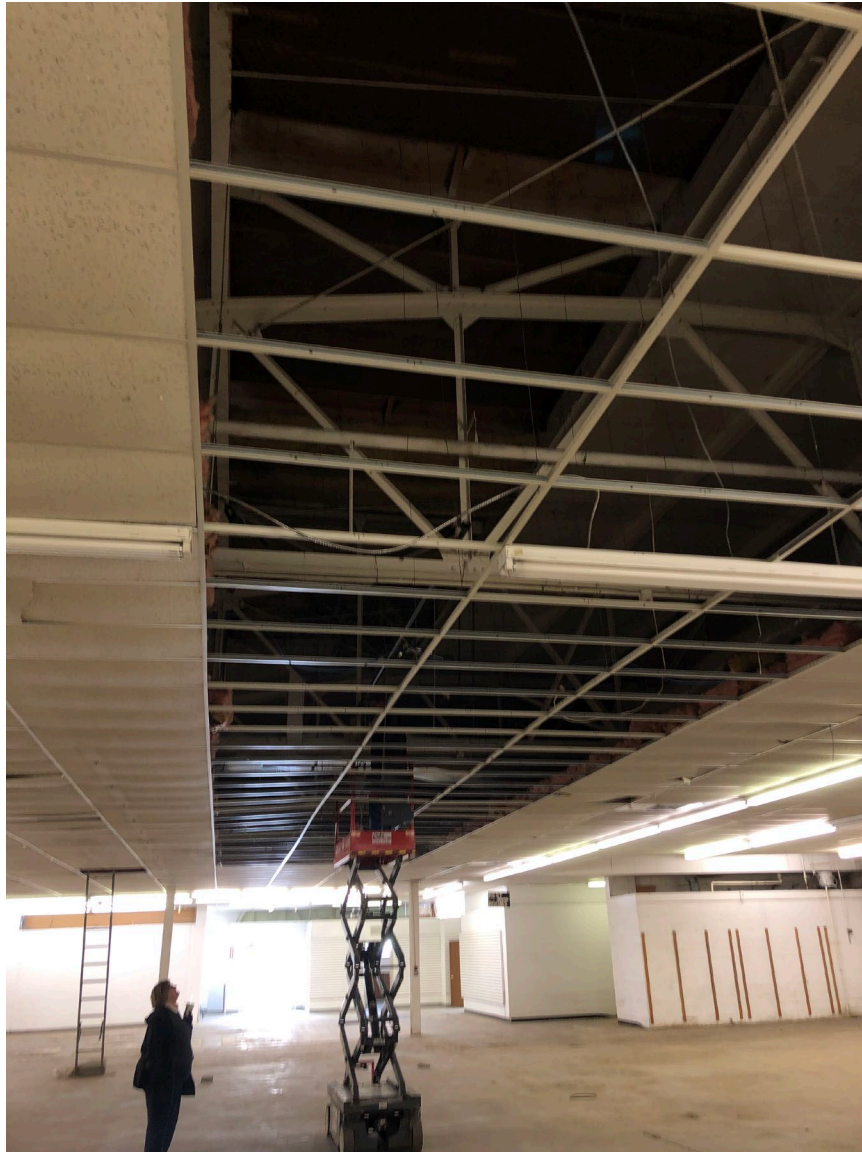
Photo #21. Roof trusses exposed looking N, shot 01-08-19.

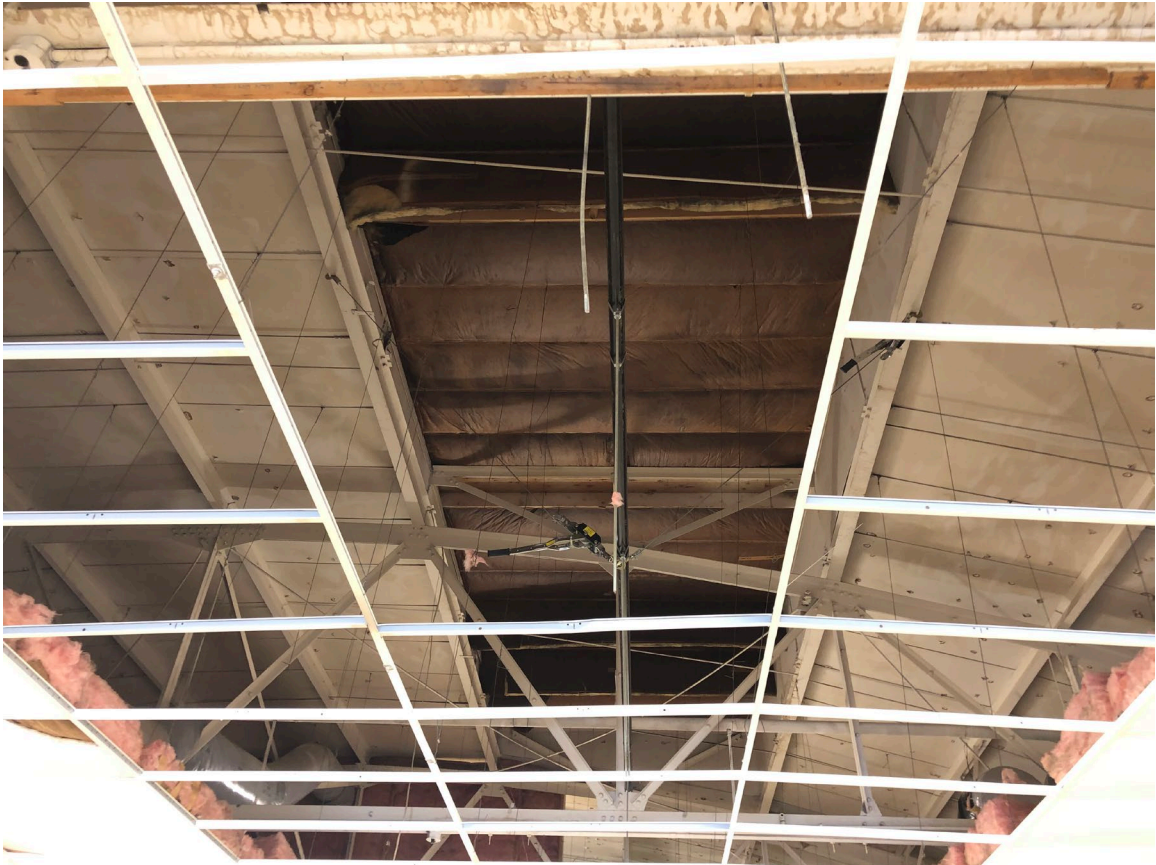
Photo #22. Skylight exposed looking N, shot 01-08-19.

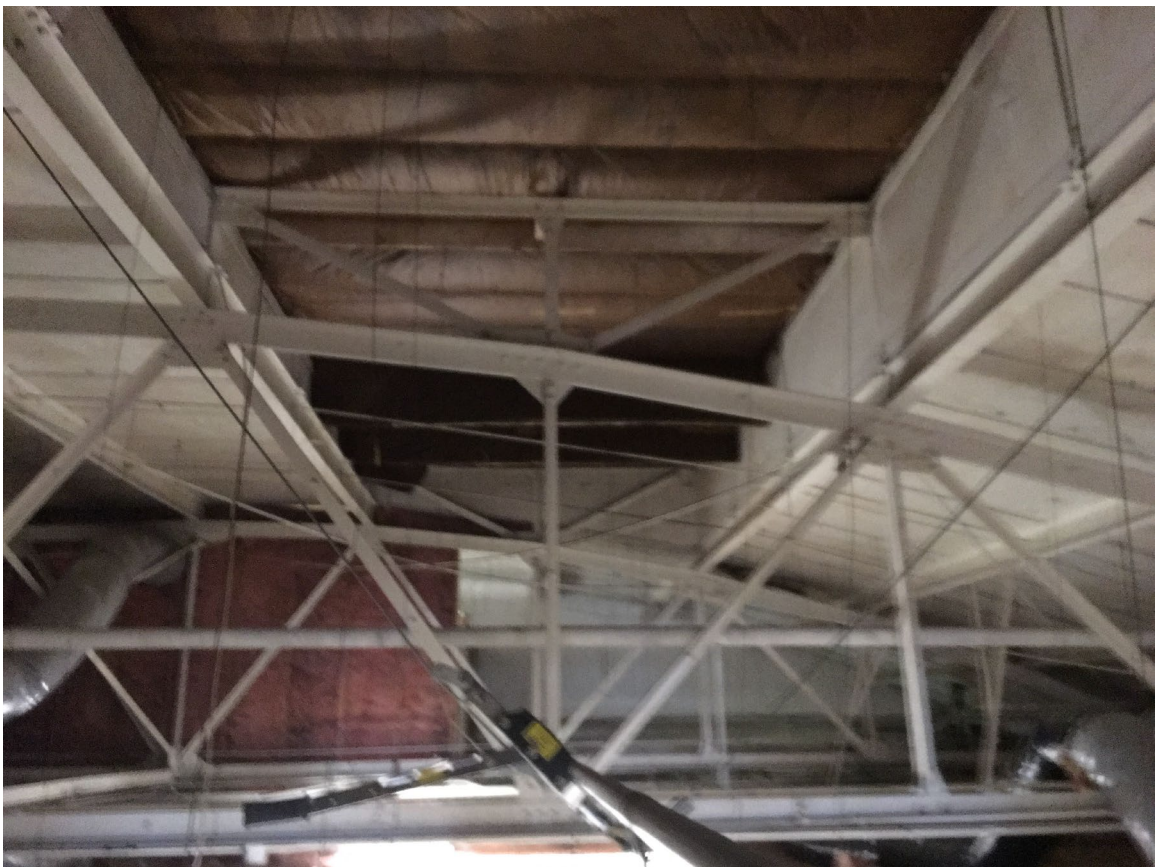
Photo #23. Bowstring trusses exposed looking N, shot 01-08-19.
